Aspects Concerning Rehabilitation of Old Masonries

Associate Prof. Eng. Ph. Dr. Proca Gabriela Technical University Jassy
Eng. Drd. Proca Cristina, Technical University Jassy

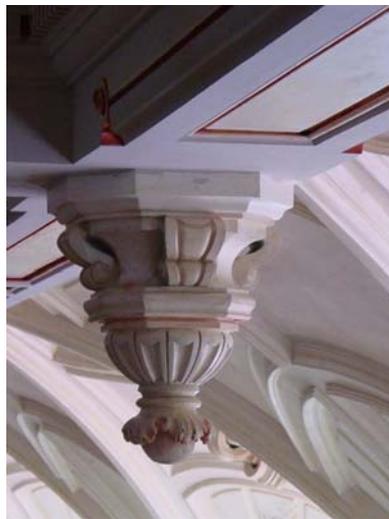
Photo 3 Rehabilitation of Paintings in Main Waiting Room

- Ensuring the water drainage with a new pipes' system;
- Masonry repair works;
- Painting rehabilitation in main waiting room (Photo 1, 2, 3);
- Changing all works made by wood with new ones, including the roof's structure;
- Modernizing all installation by changing them, with new modern ones at interior and exterior, being attentive to keep the aspect as historic monument.

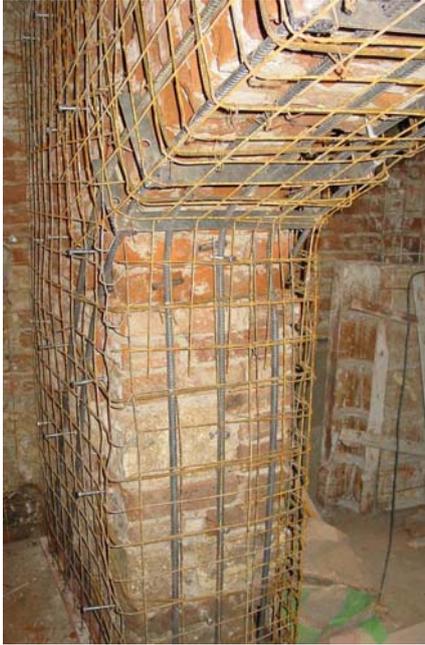
Photo 1 Alba Iulia Railway Station
– Infrastructure’s Rehabilitation

- Consolidation of infrastructure realized by masonry blocks, using supplementary Steel frames (Photo 1); and shirting structural walls with OB 37 network and concrete (Photo 2), repairing and changing installations – electrical, water- ditches (Photo 3); realizing new powerful

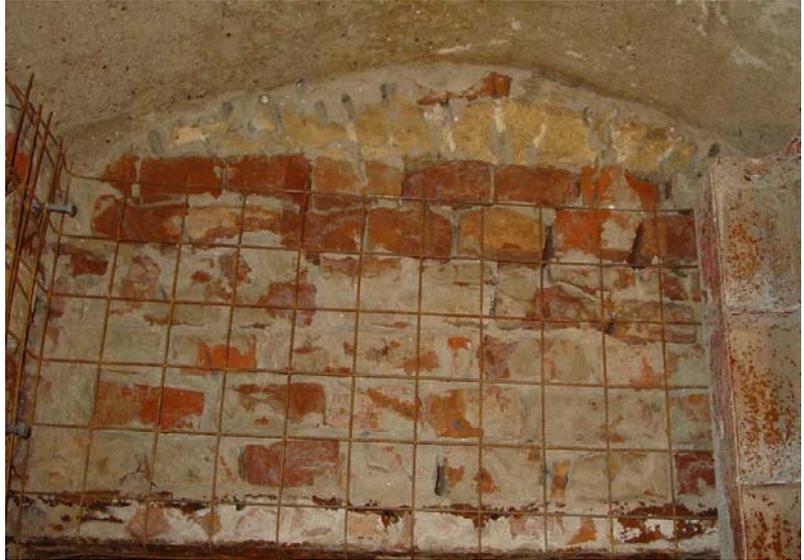
Photo 2 Alba Iulia Railway Station
- Infrastructure’s Rehabilitation

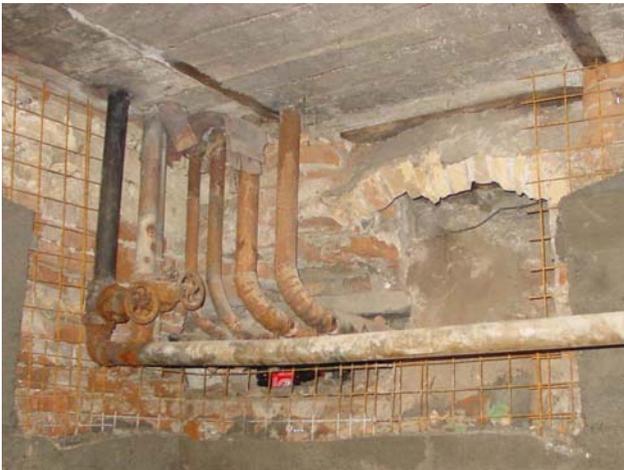
Photo 3 Alba Iulia Railway Station-
Infrastructure’s Rehabilitation of Installations

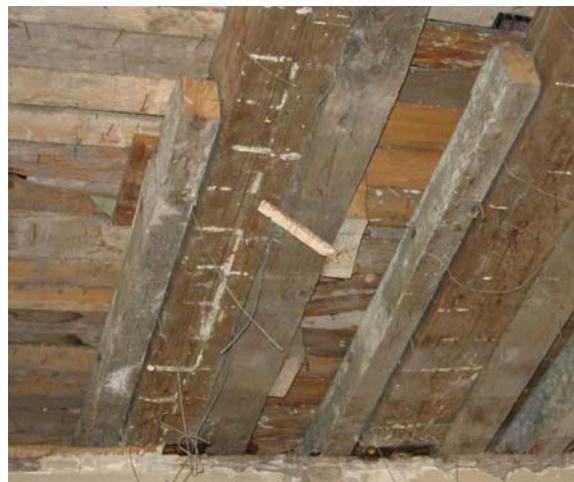
Photo 4 Replacement of wood floors in
superstructure

- Replacement of wood floors in superstructure using RC plan elements leaned against new RC restraints (Photo 4);

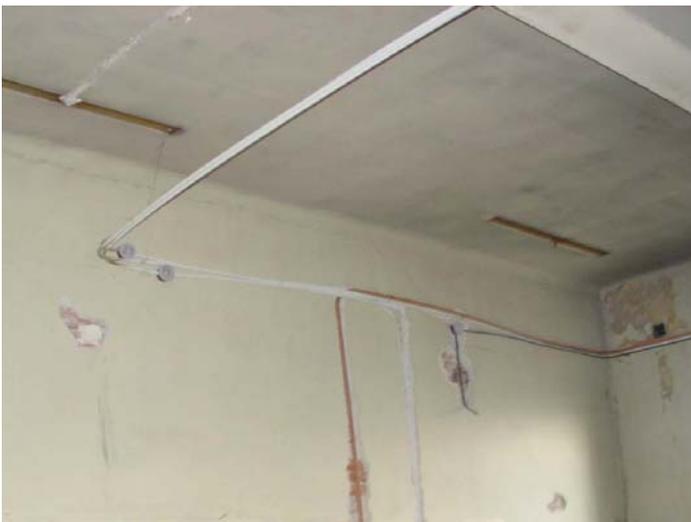
Photo 6 New Compartment and Installations

functionality, realizing new RC floors, new finishing and changing all installations systems (Photo 6, 7).

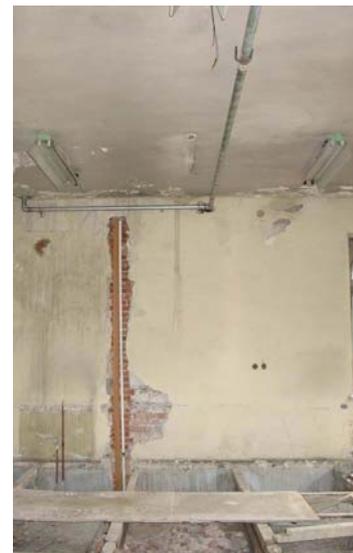
Photo 7 Arad Railway Station - Realizing new installations. Repairing an RC floor

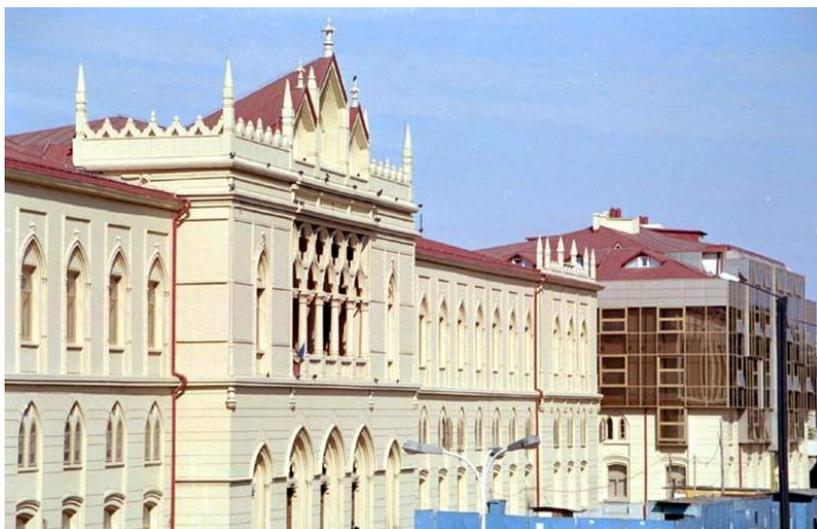
Photo 8 Iași Railway Station. Main Building

From a hand the earthquake’s activity and from the other hand the water’s raising level, were the main reasons of damages on structure and furnishings. Was decided after 1977 the rehabilitation of station’s buildings.

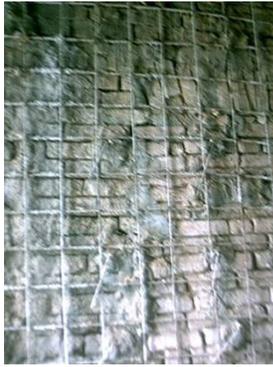
Water’s infiltration in foundation layer generated a various ram around main building (3...4 mm along transverse direction and 4...6 mm along perpendicular direction).

Photo 9
Foundations' System

The expert’s report used the simplified method in order to evaluate the resistance capacity. Because the existent structure had a reduced degree of seismic protection was necessary to draw up an intervention project. In this purpose were solved by rehabilitation: infrastructure (enlarging foundations section using natural stone and steel bares – Photo 9); shirting structural walls using RC protections; introducing new structural walls in order to reduce the distance between walls axes (Photo 10); introducing RC pillar at walls intersections (Photo 11) , RC binding over windows and doors; replacing the floors executed in wood with RC plan systems; introducing RC restraints; changing damaged structural elements of roof; introducing new installations (heat, air conditioning, water – ditches, gas, electricity).

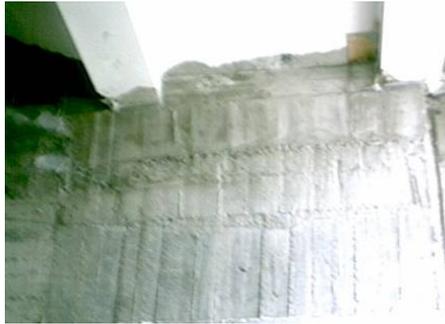
Photo 10
Supplementary structural wall
