ENGINEERING ACTIVITIES REGARDING THE STARTUP OF A METALLIC BRIDGE OVER THE CRIŞUL REPEDE RIVER

Norbert-Szabolcs SUBA, Ph.D dipl. eng., lecturer - University of Oradea, <u>suba_norbert@yahoo.com</u> Stefan SUBA, Ph.D dipl. eng., lecturer - University of Oradea, stsuba86@yahoo.com

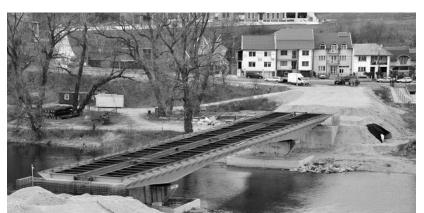
As we mentioned before, the biggest problem was represented by the fact that the bridge's deck has already been launched. Various topographical surveys have been made, and based upon them, the expertise stated that the bridge rise is currently far from being in the needed tolerances (apart from other problems). The bridge rise correction process was realized in two different sessions, each session and sub-session needing its specific precision surveying process. The two proposed sessions were:

Fig. 4. Initial state of the metallic superstructure

The first phase of the bridge rise correction process (partially ballasting the metallic structure) will basically mean that the superstructure will be transformed from console support into a continuous girder with 3 openings, and thus assuring that the superstructure is suspended on the bridge abutments. The ballasting process is made with reinforced concrete, and is achieved by flooding concrete in the encasements number 0 to 7 from each marginal console (on a total distance of 14,92 meters, from each end). The filling proportion of each cassette is 100%, and each flooding phase is followed by high precision topographic measurements (high precision levelling), in order to measure the reaction of the metallic superstructure to the stress. Unlike other geodetic works, where sampling methods can be used [Suba, 2015], this type of works requires specific measurements at all times. These measurements were carried out on each of the four longitudinal girders, at specific distances (based on the project and the key points of the structure), comparing the results both with the previous measurements and the envisioned data values.

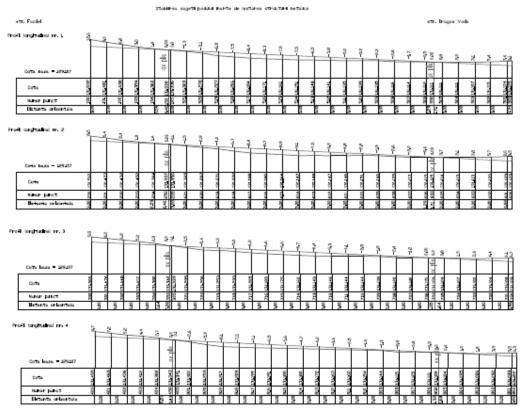
Fig. 6. Graphical and numerical representation of the measured values (one phase/all girders)

At the end of each of the prestressing phases, topographic measurements were carried out to verify the superstructure's reaction to the stressing process. After reaching the third phase, measurements have concluded that enough stressing force has been induced in the structure in order to halt further prestressing operations and continue with the construction process. All measured values have been represented as shown in Fig. 6.

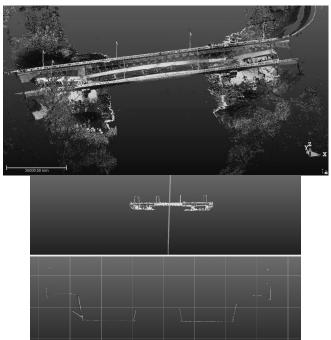
As the slabs and the concrete covered the exposed upper part of the longitudinal girders (which were used so far to measure the bridge rise modifications), we had to come up with another solution regarding the topographical measurements, in order to monitor this last major phase of the construction works. The solution was the terrestrial laser scanning method; by making precision scanning operations before and after laying the slabs and the concrete, we could measure the exact values and could add those values to the existing ones from the previous measurements.

Fig. 8. Point cloud and cross-section obtained from the scanned structure
