RESEARCH OF MORPHOLOGICAL PROCESSES INTO THE MOLDOVA RIVERBED USING PERIODIC TOPOGRAPHIC MEASUREMENTS

Abstract: *The floods occurred on Moldova River, during 2004-2015 changed the minor bed in Soci area. In this area it is embedded the undergoing Timișești-Iași adduction pipe. The undergoing section morphological changes have influenced the vertical and horizontal minor bed stability. Morphological changes were monitored by topographical surveys. The leveling surveys of research area were updated after each flood. There were made cross section and longitudinal section of the riverbed in the research area. By processing the topographical series of surveys it result the riverbed changes under the action floods. The longitudinal and cross sections indicated the riverbed hydrodynamic erosion parameters. The data collected and processed allowed the design of the breastwork in the area where the headrace ducts under-cross the river.*

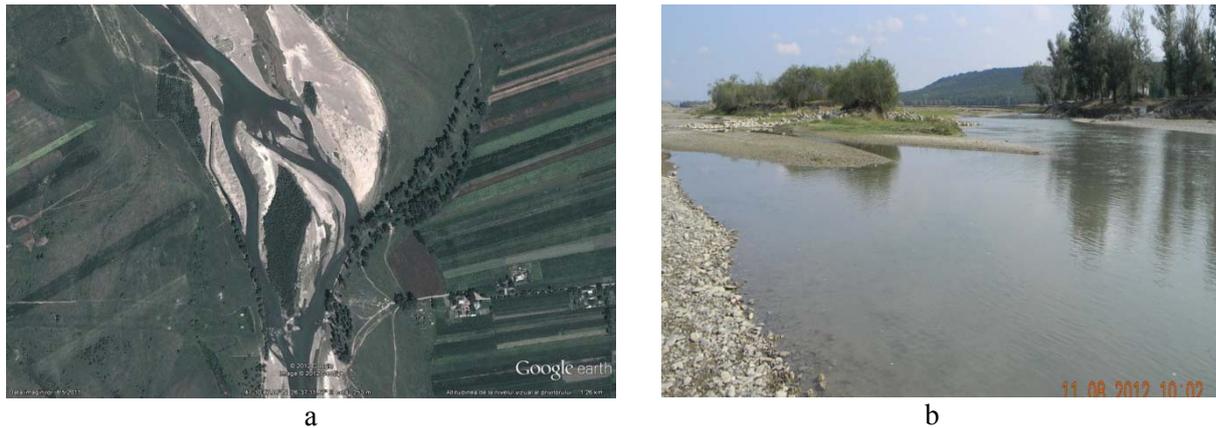
Figure 2 Pictures of the Moldova River area: a – Google earth view (2012);
b – Downstream view of the studied area

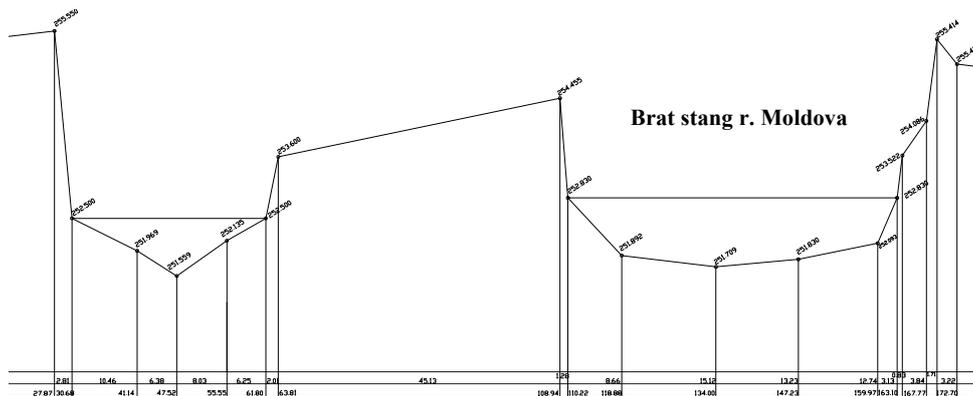
Figure 3 Cross section profile in adduction ducts undercrossing area (year 2006).

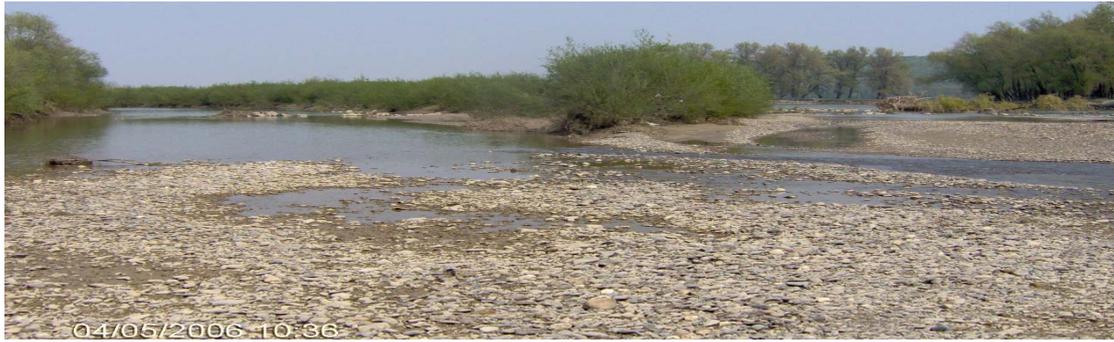
Figure 4 Downstream overview of the studied river section (left and right branches stands island and ballast foundation of the riverbed, year 2006)

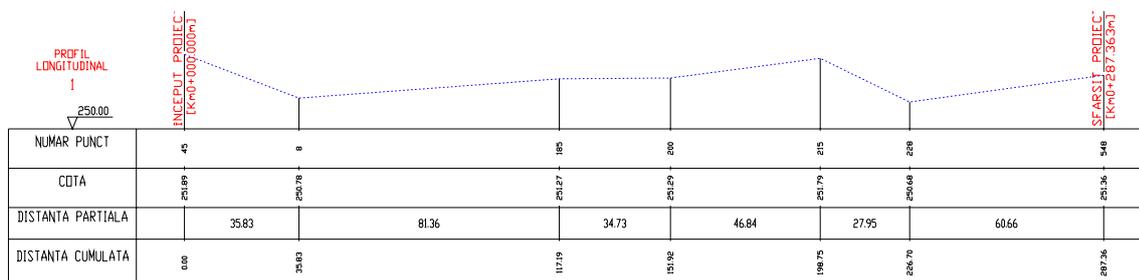
- Longitudinal profile through its two branches of the river was changed by lowering the thalweg level in the last 15 years.

Figure 5 Longitudinal profile through Moldova riverbed in the research area.

- Longitudinal profile highlights the significant slope variation in the length of the studied riverbed. In the area where the adduction ducts is produce superelevation of the bottom of the bed due to the presence of the shoulder made by the pipe.

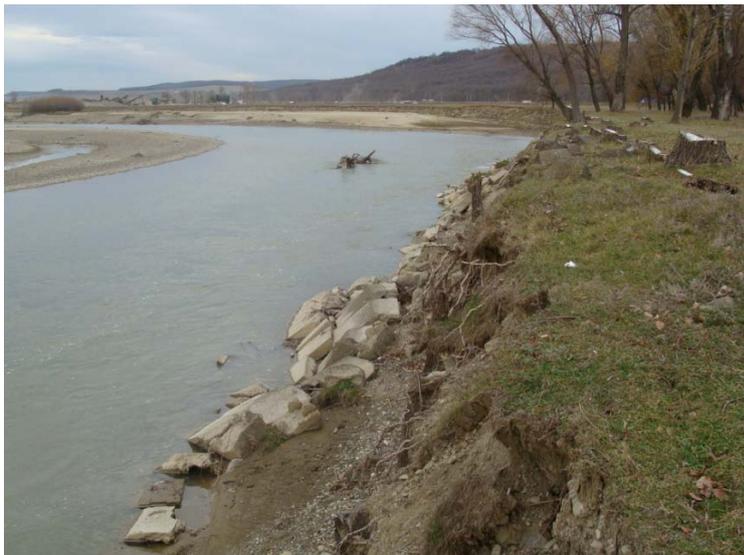
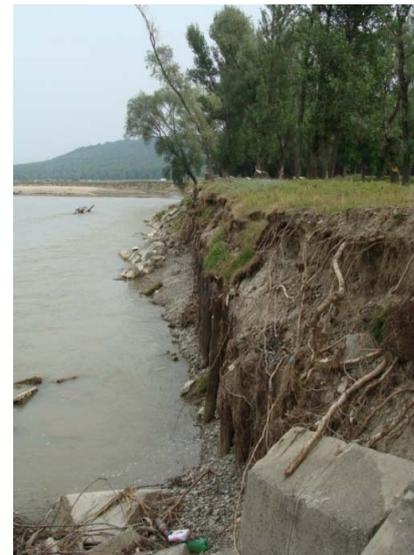
Figure 6 Degradation of left shore protection works of Moldova River after floods in 2010

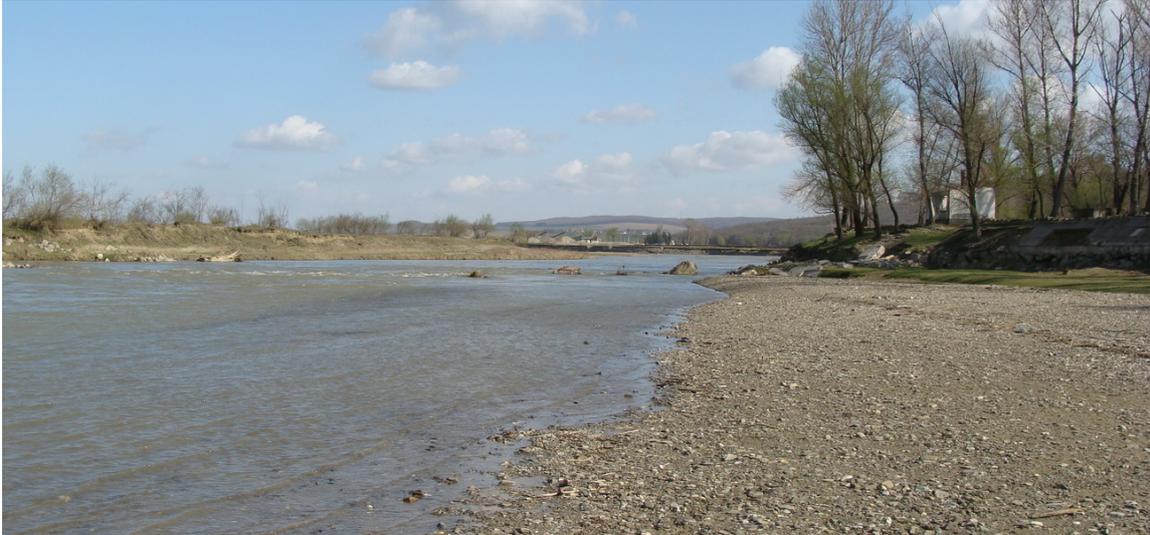
The comparative analysis made on the topographical plans and photograph mapping highlighted morphological changes in the area where the three adduction pipes undercross the river. Alluvial processes have developed to the right side of the riverbed and especially around the island. Erosion processes were developed left bank. Left bank erosion intensified in 2005 and was manifested by washing alluvium, degradation and total destruction of bank protection etc. Excavating ballast upstream undercrossing influenced the intensification of hydrodynamic erosion.

Figure 7. Downstream overview downstream of the left arm of river in the study area (year 2015)
