CONSIDERATIONS ON NON- DESTRUCTIVE MONITORING METHODS USED IN MASONRY STRUCTURE CONSTRUCTIONS' EXPERTISE OF THE EXISTING BUILDING STOCK

*Gabriela Ecaterina PROCA, Assoc.Prof.Ph.Dr.Eng., Technical University "Gh.Asachi"
Jassy, gabriela_proca@yahoo.com*

Abstract: *In the context of building construction works from existing building stock, the paper presents considerations regarding the monitoring methods used in heritage buildings in Romania and constructive implications necessary for structural consolidation.*

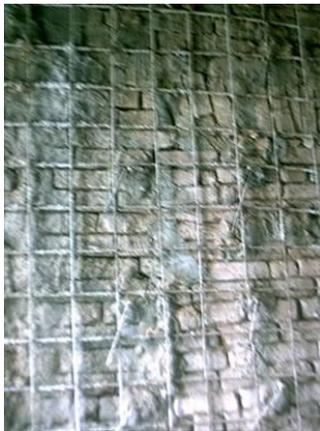
Fig. 2

a. Underpinning foundations

Consolidation solutions were to increase the foundations underpinning section using natural stone blocks, structural walls were strengthened at junctions and branches with masonry pillars; lintels and masonry structural walls were clad. Additionally, cross diaphragms were introduced monolithic reinforced concrete for reinforcement of structural elements. (Fig. 2).

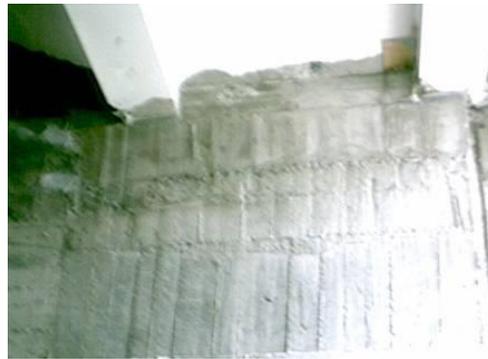
b. Reinforcing concrete diaphragm

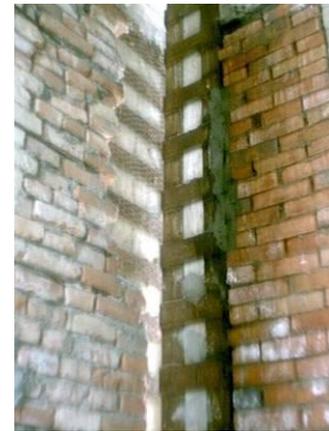
c. Reinforced concrete pillars at the intersection of load-bearing walls

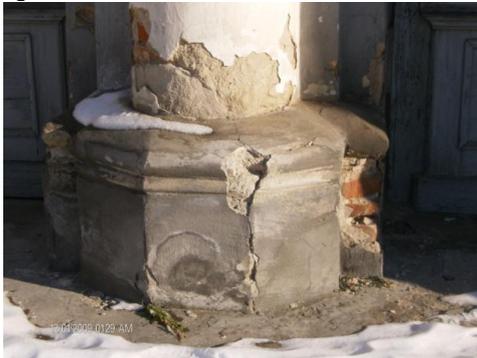
Fig 3

- Road, poorly maintained building, with parallel role to bypass heavy traffic transiting important city generates vibrations which are transmitted to the building site and generating separation of mortars substrate (fig. 3) and cracking joints (fig. 4);

- Reduced distance to one of the neighbouring buildings (left side) led to increased damage while mentioned , due to the influence of the technologies used in construction, demolition and reconstruction (fig. 3-4) ;

In this case, the rehabilitation works are: restoration of plasters and sealing cracks, replacing all installations and wood joinery.

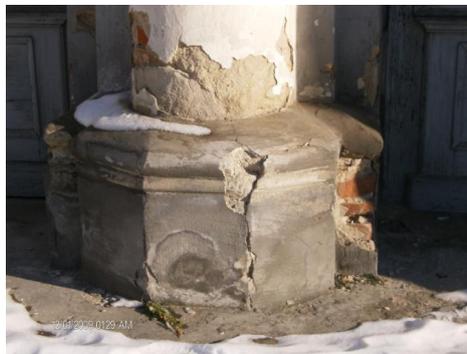
Fig. 5

- Sudden temperature changes day - night, low temperatures a number of days annual rainfall which works with sheet metal damage, favors additional intake of moisture to the outer walls (fig. 5);

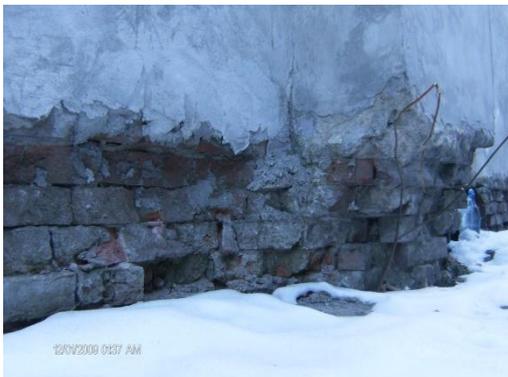
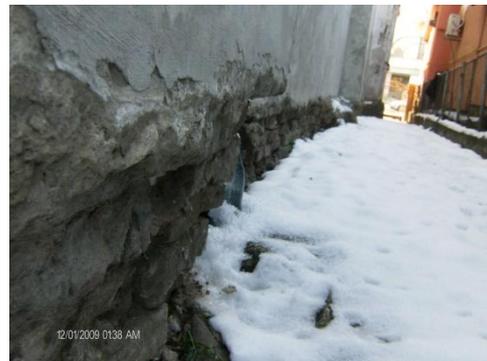
- Abandoning rehabilitation and implicit lack plinth masonry structure exposed directly to water and freezing- thaw phenomena (Fig. 6-7) ;
