ASSESSMENT OF HYDROMORPHOLOGICAL AND HYDRODYNAMIC ALTERATIONS CAUSED BY ANTHROPOGENIC INTERVENTIONS ON THE RIVERBED. CASE STUDY DANUBE BALA BRANCH NEW BOTTOM SILL

Abstract: *The necessity for navigation conditions improvement on the Lower Danube lead to the construction of a submerged bottom sill on the Bala branch. This paper presents differences that occurred between riverbed bathymetry and water current velocity values recorded in measurements campaigns using multibeam and ADCP techniques carried out before and after the bottom sill was built (June 2013 and March 2016). The comparative hydromorphological analysis showed the emergence of erosion areas up to -17.4 m and deposition areas up to 9.5 m. As for the hydrodynamic alterations, above the new built bottom sill, the water current velocity values of over 3.0 m/s were recorded.*

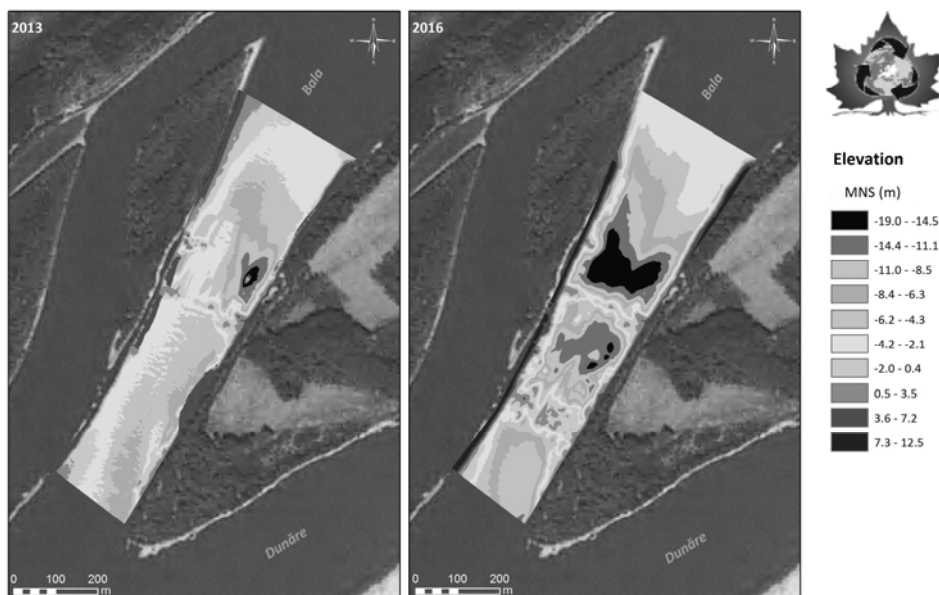
In order to highlight the morphological changes that took place in the area of the new built bottom sill on the Bala branch, using multi-beam bathymetric measurements, in Fig.2 is represented the riverbed bathymetry from June 2013 vs. March 2016.

Fig. 2. Riverbed bathymetry – Bala branch – pre and post - construction period

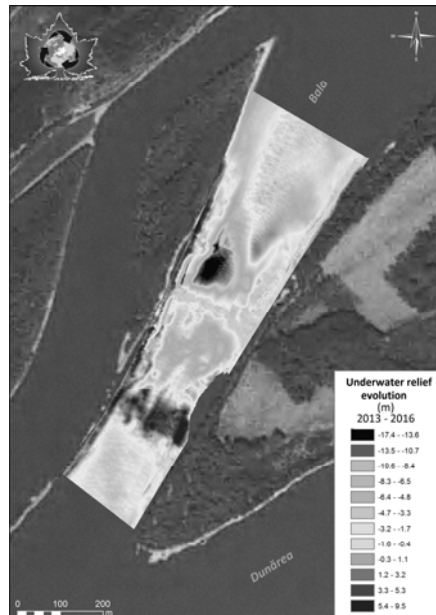
Fig. 3. Changes in riverbed bathymetry 2013 vs 2016

As can be seen in Fig.3, erosion up to -9.2 m is evident in the upstream area of the new bottom sill, value recorded towards the right riverbank. In Fig.3, the new bottom sill appears as a deposition area of up to 9.5 m. The sector between the two bottom sills is characterized by erosion areas of up to -10.5 m.

Erosions also resulted in the area of the old bottom sill, the values being around -5.4 m. Immediately downstream of the old bottom sill can be noted, towards the left bank, an area with erosions up to -17.4 m. The fact that before the hydraulic works began in June 2013, downstream of the old bottom, there was an erosion pit at the right bank, it can be said that at the level of 2016 it has deepened and extended to the right bank.

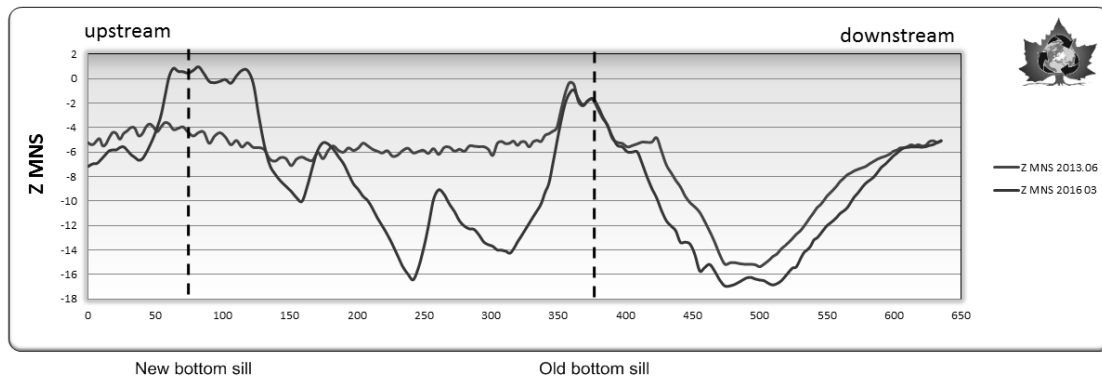
Fig. 4. Riverbed bathymetry SLCB1– June 2013 vs March 2016

On this section we can see that, in 2016, erosion zones were formed upstream and downstream of the new bottom sill. Also, the scour hole formed downstream of the old bottom sill, has widened compared to the period before the start of hydrotechnical works.

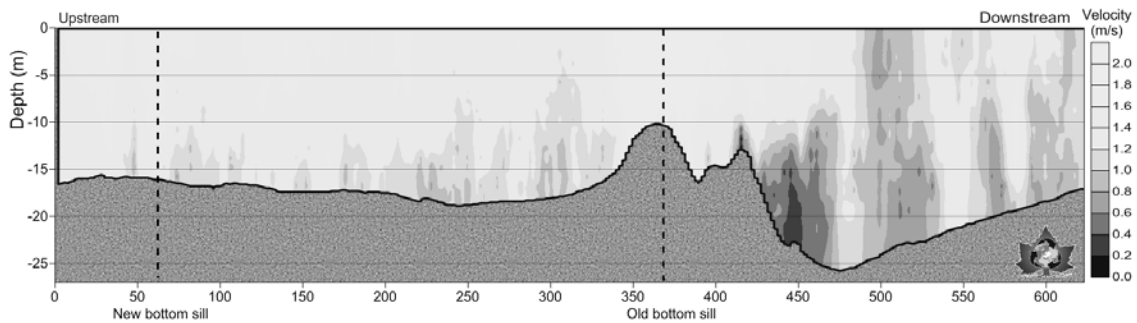
As for the water current velocity distribution on the SLCB1 longitudinal section (Fig.5) in the pre-construction phase, peak values of approx. 2.0 m/s were recorded above the old bottom sill.

Fig. 5. Water current velocity distribution – pre-construction phase 2013- SLCB1

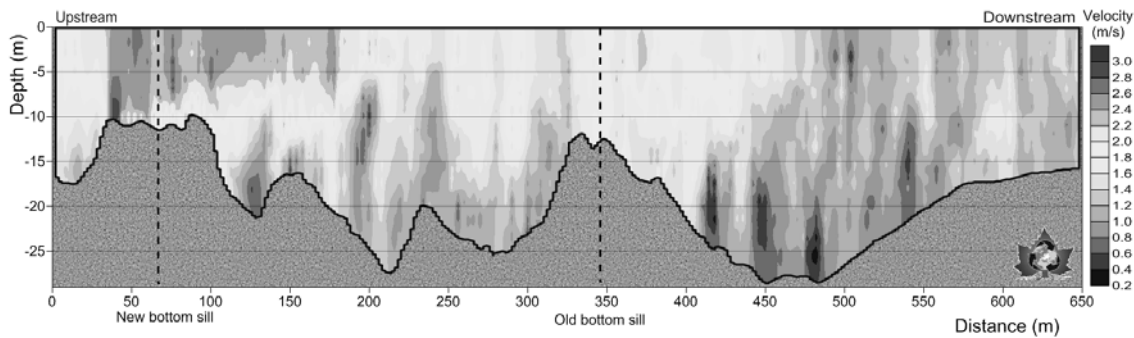
Figure 6 shows the distribution of water current velocity in the post-construction phase with maximum values of over 3 m/s above the new bottom sill.

Fig. 6. Water current velocity distribution – post-construction phase 2016- SLCB1

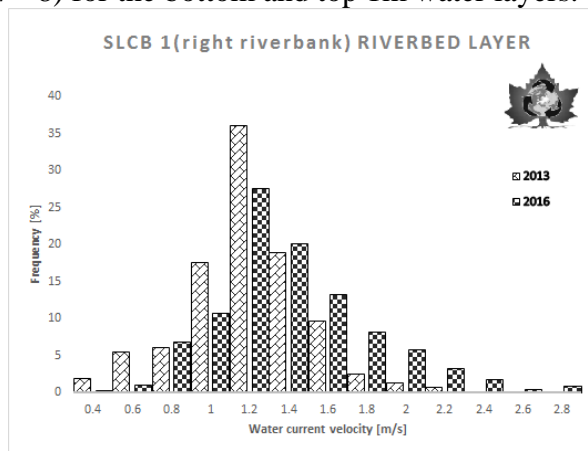
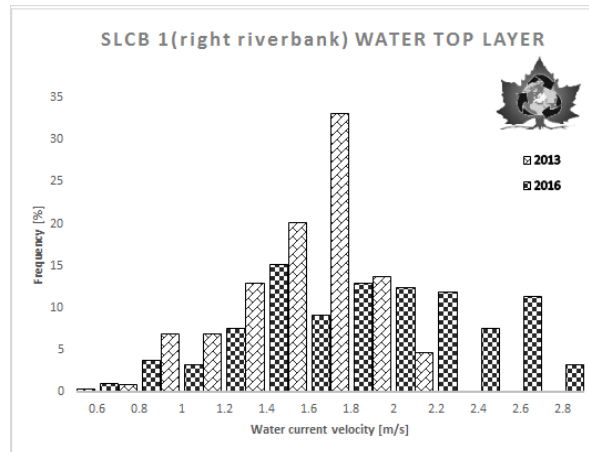
Fig. 7. Water current velocity frequency distribution – SLCB1 - June 2013

Fig. 8. Water current velocity frequency distribution – SLCB1 - March 2016

For SLCB 1 control section, it can be noted that for both the riverbed layer and the water top layer, the histogram shape differs between the two periods. Thus, for 2016 the recorded velocity range increased from maximum values of 2.2 m/s for 2013 to water current velocity values of 2.8 m/s for both considered layers.

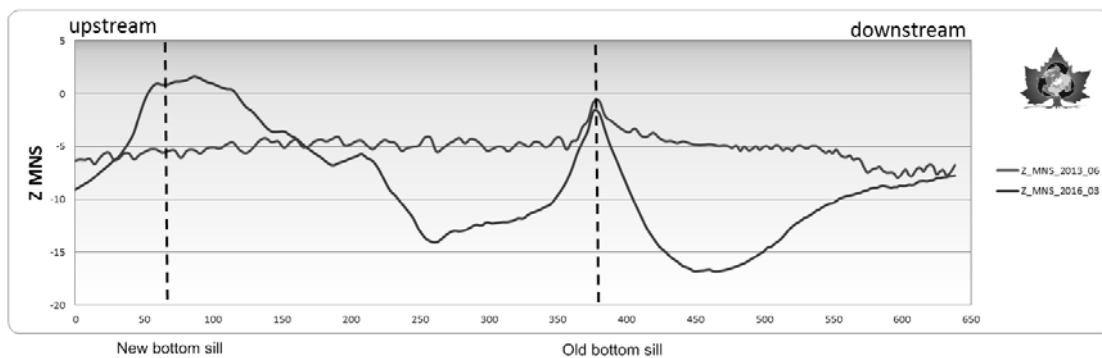
The SLCB2 control section is located at the center of the Bala arm (Fig.1). According to Fig.9, it can be noticed that a scour hole was formed immediately downstream of the new bottom sill. At the same time, upstream of the new hydraulic construction, it can be noted one erosion area of up to 5 m. Downstream of the old bottom sill, the scour hole that was located in the pre-construction phase near the right bank has expanded until 2016.

Fig. 9. Riverbed bathymetry SLCB2– June 2013 vs March 2016

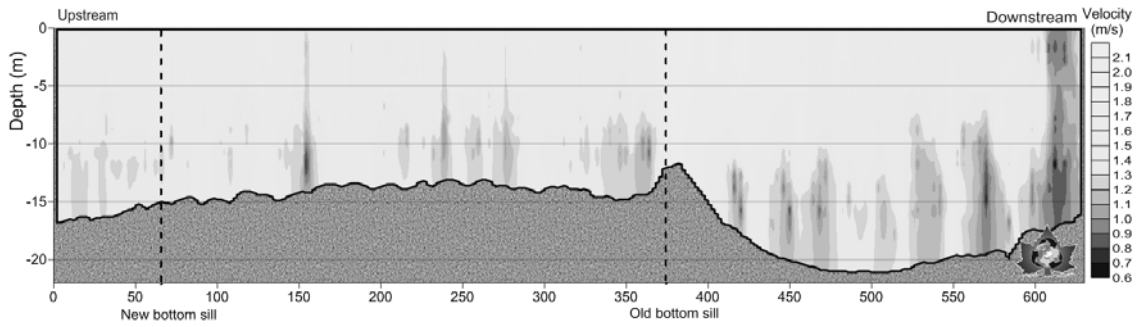
As for the distribution of the water current velocity, as in the case SLCB1 control section, it is worth mentioning that during the pre-construction period the maximum values were approx. 2.0 m/s, the maximum being recorded at the old bottom sill (Fig.10).

Fig. 10. Water current velocity distribution – pre-construction phase 2013 - SLCB2

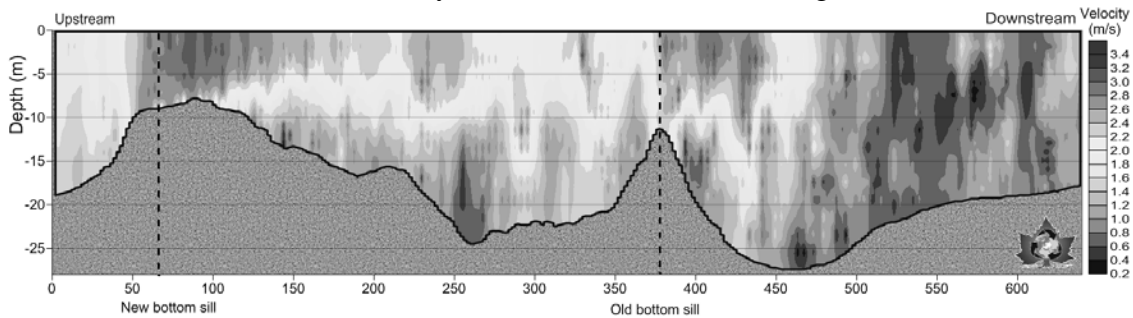
In the post-construction period, as a result of flow section reduction, the maximum values of the water current velocity values are about 3.2 m/s (Fig.11).

Fig. 11. Water current velocity distribution – post-construction phase 2016- SLCB2

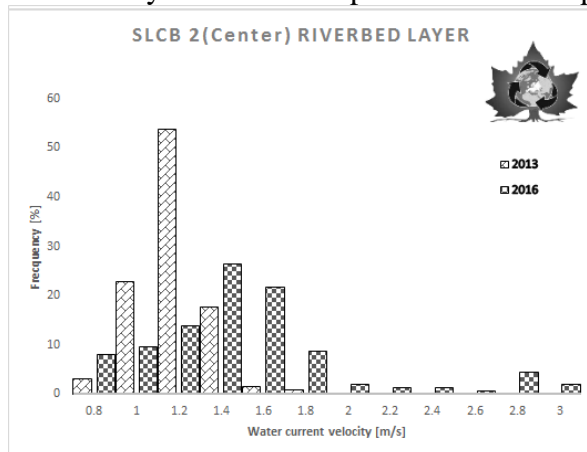
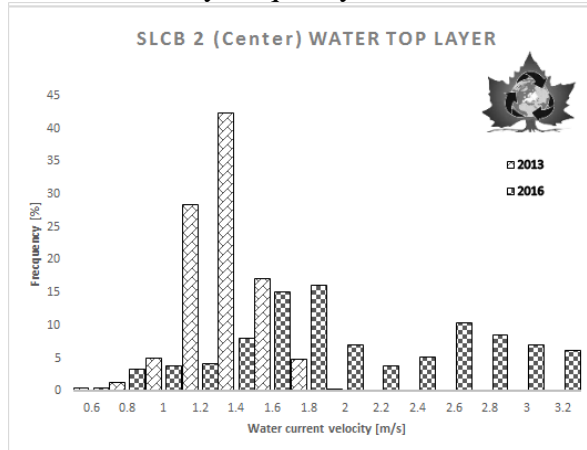
Fig. 12. Water current velocity frequency distribution- SLCB2 - June 2013

Fig. 13 Water current velocity frequency distribution- SLCB2 - March 2016

As can be seen in Fig.12 - 13 for SLCB 2 control section, in 2016 the maximum velocity values range from 3-3.2 m/s, compared to the 2013 maximum values of around 2 m/s. The highest frequency velocity values are about 1.2 m/s (riverbed layer - 2013), 1.4 m/s (riverbed layer - 2016 and water top layer - 2013) and 1.8 m/s respectively (water top layer - 2016).

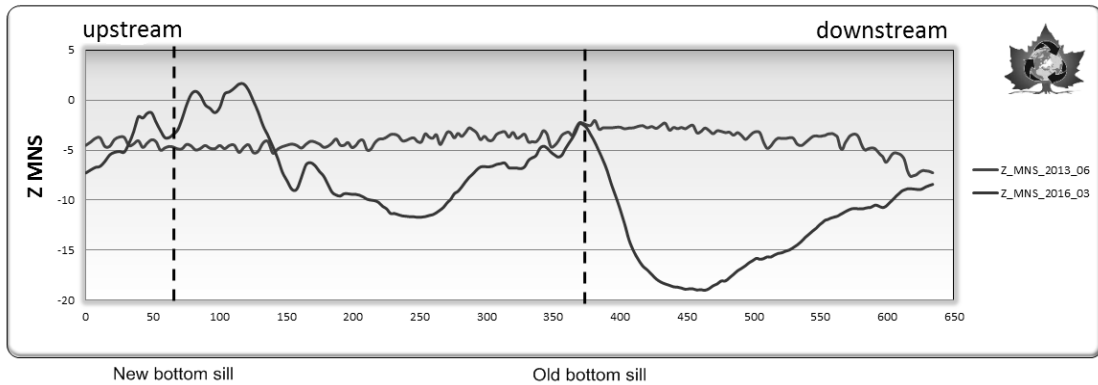
In the case of the **longitudinal SLCB3 control section** located near the left bank of the Bala branch (Fig.1), from the point of view of the riverbed geometry, it can be observed that in 2016, similar to the analysis shown for SLCB2, a new scour hole was formed by the new bottom sill, and downstream of the old bottom sill is visible the scour hole that extended from the right bank (see Fig.14).

Fig. 14. Riverbed bathymetry SLCB3– June 2013 vs March 2016

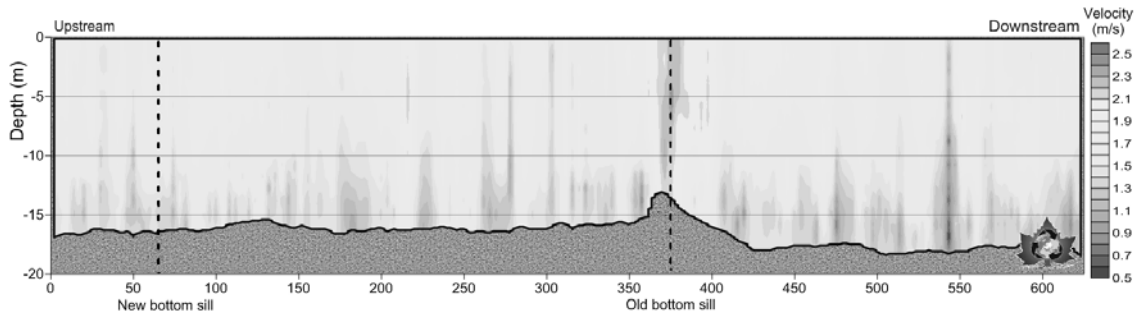
Unlike the other two sections, in the longitudinal section near the left bank, during the pre-construction period, higher water current velocities were recorded, the maximum values being about 2.5 m/s (Fig.15).

Fig. 15. Water current velocity distribution – pre-construction phase 2013- SLCB3

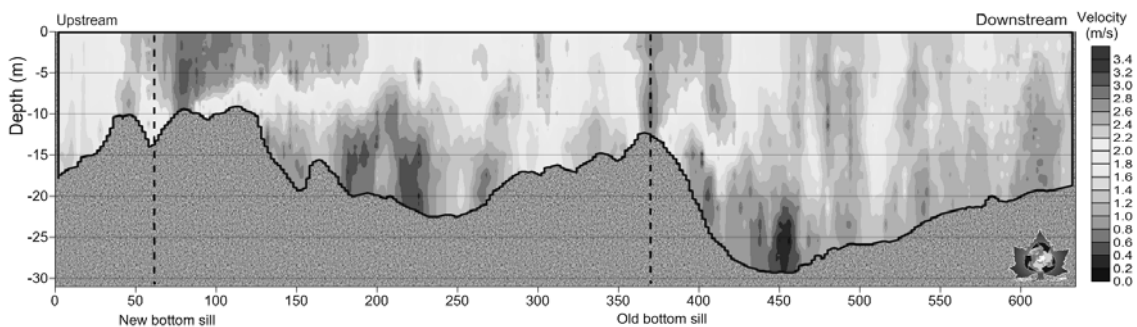
In the post-construction period, there were recorded maximum values of the water current velocities of approx. 3.2 m/s, above the new bottom sill (Fig.16).

Fig. 16. Water current velocity distribution – post-construction phase 2016- SLCB3

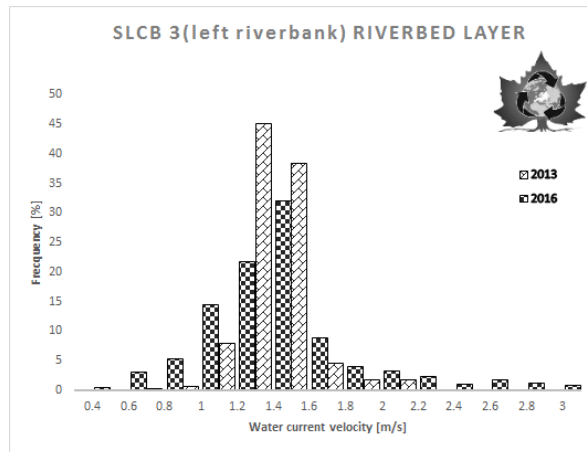
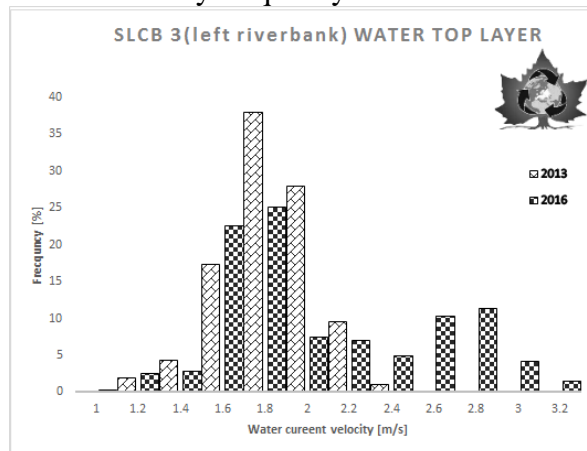
Fig. 17. Water current velocity frequency distribution - SLCB3 - June 2013

Fig. 18. Water current velocity frequency distribution - SLCB3 - March 2016

For SLCB 3 longitudinal control section, as shown in Fig. 17 - 18, in 2013 the maximum recorded velocity values were around 2.2 m/s (riverbed layer) and 2.4 m/s respectively (the water top level), and for 2016 these values increased to approx. 3 m/s (riverbed layer) and approx. 3.2 m/s (the water top level).

For the riverbed layer, the highest frequency for the water current velocity was recorded for the 1.4 m/s values for both 2013 and 2016. The same trend is also observed for the water top layer with values around 1.8 m/s presenting the topmost frequency.
