STUDIES REGARDING THE SAFETY IN OPERATION OF MILEANCA RESERVOIR

Abstract: *The dam of Mileanca reservoir, located on Podriga river, is an earth dam with a maximum height of 10,08 m, that provides a global retention to the canopy of 11,116 hm³. Mileanca reservoir is one of the hydrotechnical constructions that were build to protect against the floods downstream villages: Mileanca, Drăguşeni, Havârna, Scutari, Ştiubieni, Săveni. Between the years 2008 and 2012 investment works were implemented, under the project „Safety re-inforcement of Mileanca reservoir, located on Podriga River, in Botoşani county”. The project was set out to build the following works: rehabilitation of dam body (repairs to the concrete tiles on the downstream slope, sealing screen), rehabilitation of the hydromechanical equipments, rehabilitation of the bottom outlet, rehabilitation of the evacuation channel of the surface outlet, installation of a water management information and warning-alarm system, rehabilitation of the behaviour monitoring system. This paper presents a brief history of the dam in its construction and exploitation phases, focussing on aspects regarding the behaviour monitoring of Podu Iloai

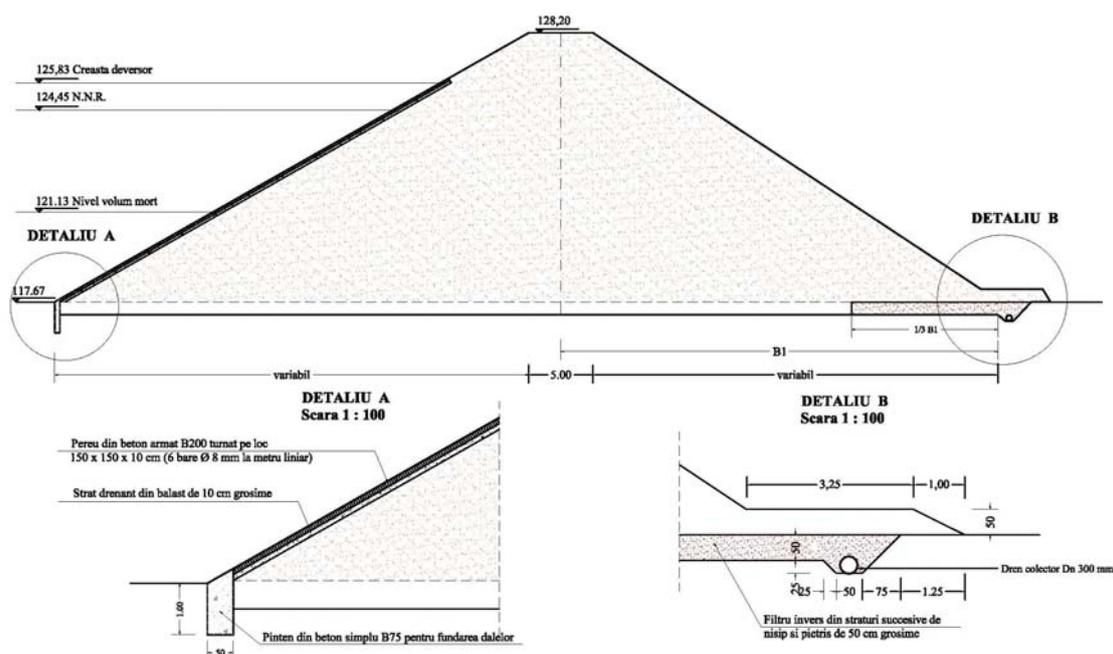
Fig. 2. Cross section of the dam body

Retention in Mileanca reservoir is made by a frontal dam made of silty clay, with a canopy length of 458 m, and a width of 5.0 m. The dam is provided with a drainage mattress of 0.5 m, located in the downstream third of the footprint base. Drainage culvert for water collection and drainage is 300 m long and consists of polyvinyl chloride pipes with Dn 300 mm.

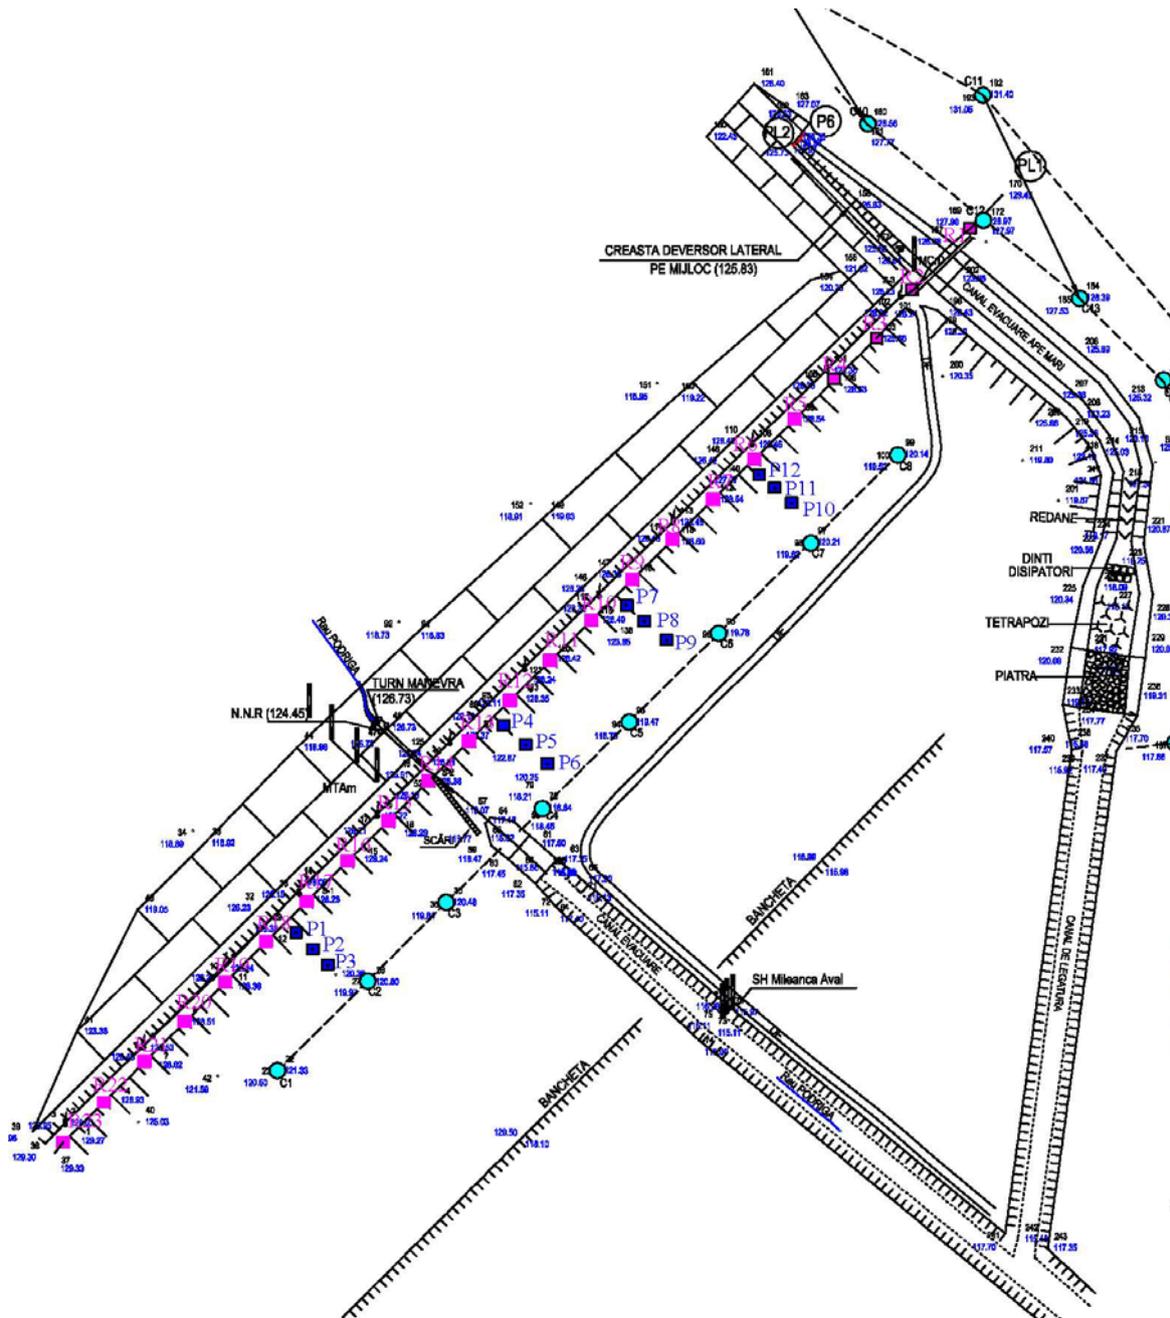
- 1 fixed landmarks (in the left embankment of the dam);
- 2 fixed landmarks (in the right embankment of the dam);
- 1 landmark on the support pillar;
- For tracking the evolution of body dam seepage 12 piezometric wells, 8 seepage sewers and 2 outlet conduits for the dam seepage in the left and right branch in the bottom outlet channel are used;
- For tracking the evolution of seepage in the left embankment 10 seepage sewers and 1 outlet conduit for the embankment seepage in the evacuation channel of the surface outlet are used; (Figure 4).

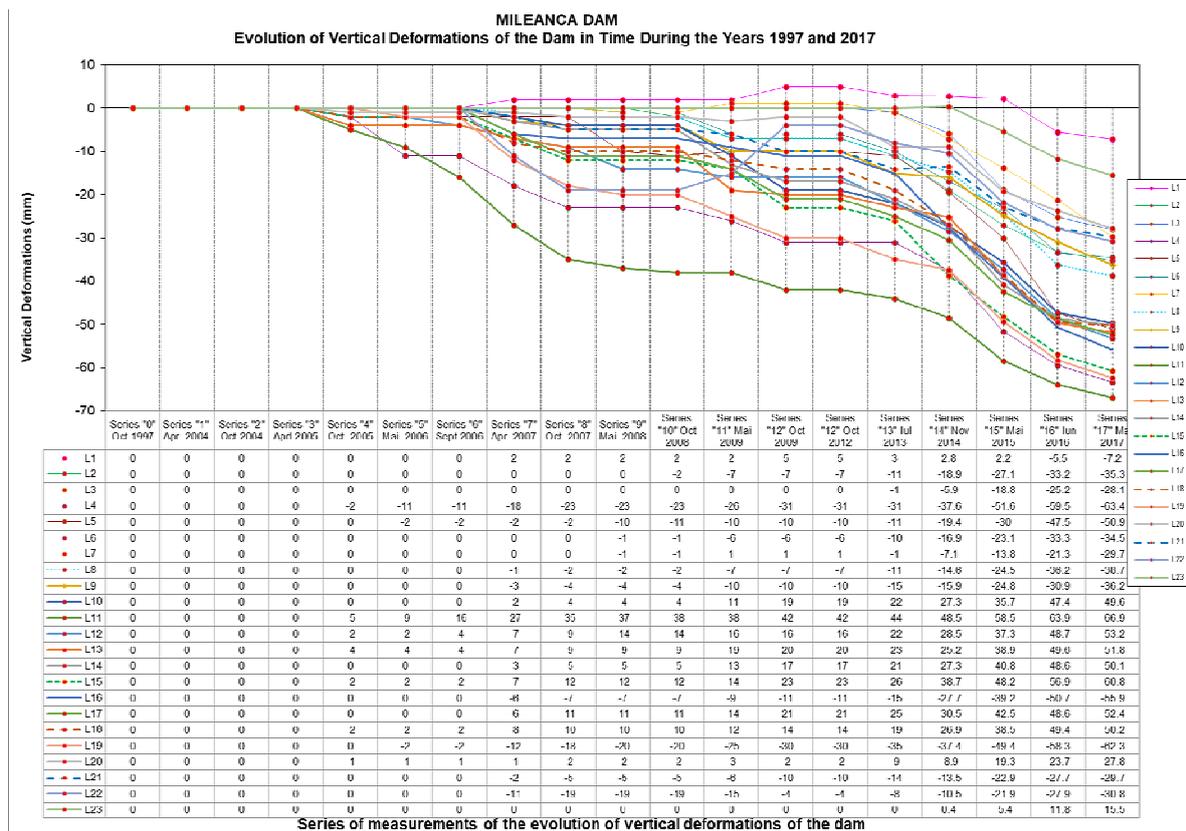
Fig. 5. Evolution of Vertical Deformations of the Dam During the Years 1997 and 2017

By analyzing the temporal evolution chart of the vertical deformations we have observed a normal evolution of the compaction phenomenon. (*Figure 5*)
