INTERVENTION MEASURES ON BUILDINGS AFFECTING BY HUMIDITY

The present study refers in particular to the issue of the building from the point of view of the causes of excessive humidity in the underground area, the effects produced and the necessary measures, the analyzed building being a dwelling house, built in 1940, having a height regime S + GF + E (basement, ground floor, floor).

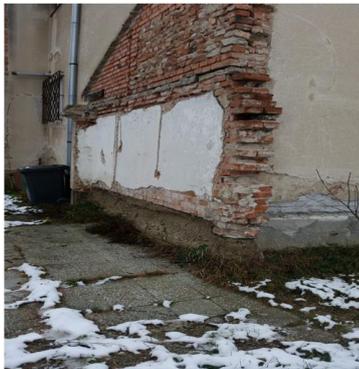
- it is also possible to observe the existence of a horizontal waterproofing at the upper level of the exterior walls of the basement (Figure 1);
- on the corner of the building, on the rear facade, respectively the left side façade, there can be noticed cracks as well as the inclination of the stair house towards the exterior of the building. (Figures 2, 3);

Fig.1 Slope Deterioration - Right Side Facade

- degradation of the concrete socket due to excessive humidity (probably using a lower concrete class and possible chemical aggression of groundwater) (Figure 1);

The following intervention measures are based on economic considerations regarding the approximate cost of building protection, so for degraded basin rehabilitation interventions it is proposed to create a shingle which has a SPB Φ 5#100X100mm welded mesh attached to the socket by means of anchors made of PC52 Φ 12 (9pieces/m²) and having the dimensions 15x35. The anchors will be embedded in the socket by means of an epoxy resin adhesive, and then the C20/25 concrete will be cemented and cast in a thickness of 10 cm (Figure 1).

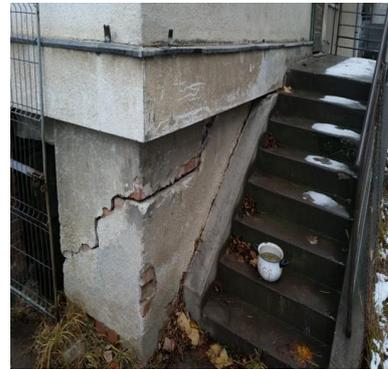
Fig.2 Cracks in Rear Facade

- compressing / inclining towards the exterior of the staircase building at the secondary entrance (figures 2 and 3);
- the appearance of cracks in the corner of the building, the rear facade and the left side facade due to the compaction of the respective corner area (figures 2 and 3), the water infiltration due to water;

Rehabilitation interventions on the corner of the building - the rear facade and the left side facade (figure 2, figure 3) will be made from the outside of the building and the consolidation of the foundation will be done by reinforcing with C16/20 reinforced concrete. Subsoiling will be done on sections of up to 80cm length with a pitch of about 2.0m to a depth of 2.8m.

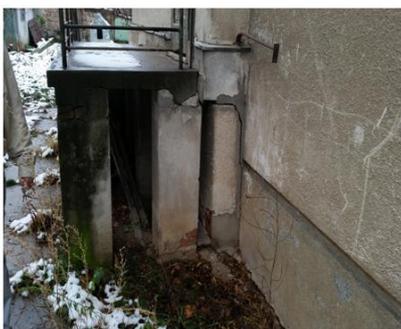
Fig.3 Cracks in the left side facade

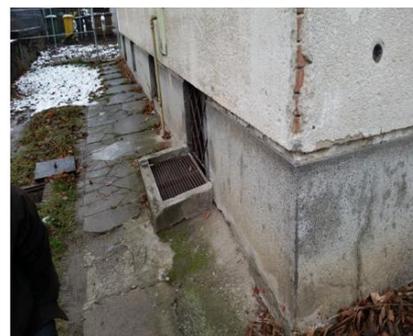
- there is no pavement on the entire perimeter of the building, except for the main façade where it exists but is degraded (Figure 4);
- the windows in the basement area have light courtyards that may have areas where water is infiltrated (Figure 5);

Fig.4 The front side pavement

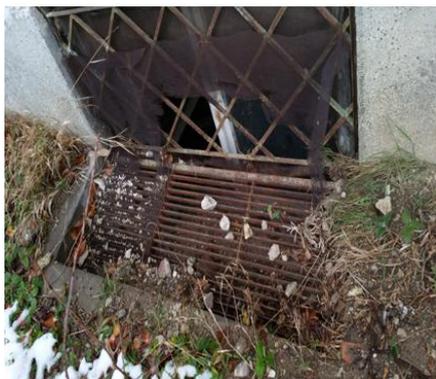
Fig.5 Position the windows in the basement

- the courtyards of light will be completely demolished and others will be made in their place;
- all water and sewerage systems will be replaced.

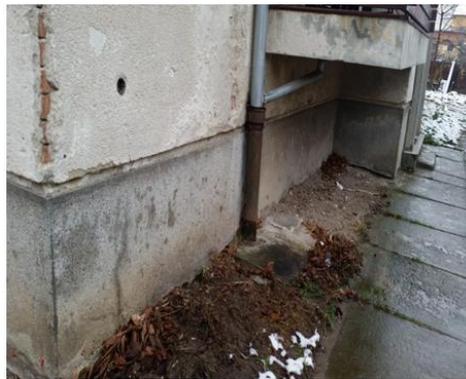
- from those observed on-site, pluvial water take-backs in the ground were not changed (Figure 6);
- the exudation phenomenon is present, which is represented by lime deposits occurring in certain cases in joint mortars and brick masonry (Figure 7);

Fig.6 reception facilities rainwater into the ground

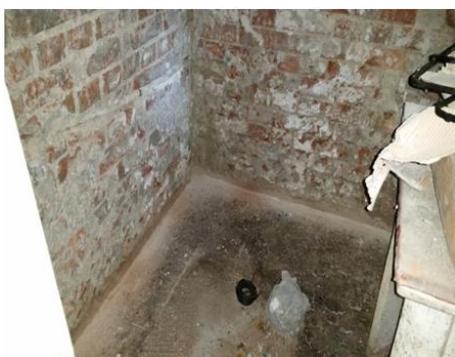
Fig.7 Lime deposits on mortar

- the occurrence of the exudation phenomenon (Figure 7) which does not pose a danger to the building because there is no double circulation of moisture from the outside to the inside and vice versa on the same face, the only problem identified being aesthetic if the masonry would not be plastered.

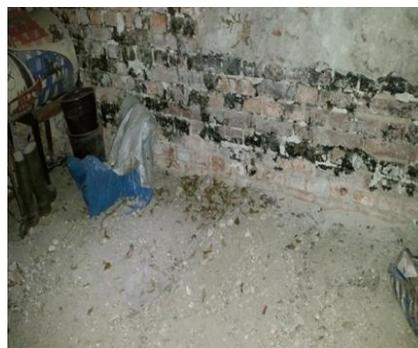
- on one of the exterior walls on the main façade an inefficient intervention was carried out over time with the application of a molten bitumen layer (Figure 8).

Fig.8 Ineffective intervention by application of a molten bitumen layer

- clean the bitumen on the exterior wall of the main facade before applying the plaster;
- the chimney flue ducts that are obstructed will be put into operation as they constitute a natural way of ventilating the basement;

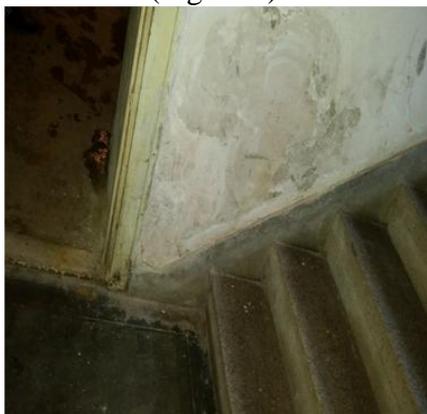
At the same time measurements were made with the humidity meter Testo 606 and it was found that the humidity of the basement walls is 10-12% below the value of 5-7% considered normal humidity. Exceptions to the above mentioned are the basement walls, including the walls of the stairwell, in the sewage area where the measurements indicated a very high humidity with a value of over 30% (Figure 9).

Fig. 9 Moisture-affected area - route area of the sewage system

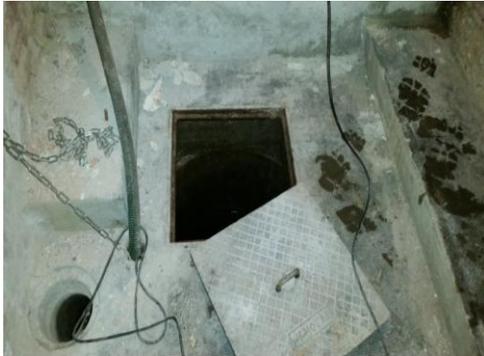
- in the basement of the building there is an absorbent well provided with a pump that maintains the level of the ground water bed at a constant level (figure 10);

Fig. 10 Absorbent hose with pump

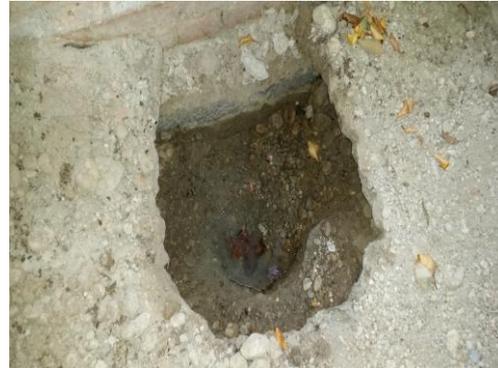
- in the basement of the building were identified horizontal drainage made of ceramic drain elements located at approximately -0.30m, -0.35m compared to the floor basement floor;
- as a result of the on-site surveys, it can be seen that the groundwater level is very high (Figure 11), the property being located near the Trinckbach brook.

Fig. 11 Identification of groundwater level
