TRACKING VERTICAL MOVEMENTS OF THE SURFACE ASSOCIATED TO A CLOSED MINE

Abstract: *The paper aims to monitor through topographic, planimetric and leveling measurements, the soil stability and to track the constructions within the influence perimeter of Victoria salt mine, in order to protect the surface and objectives in the area.*

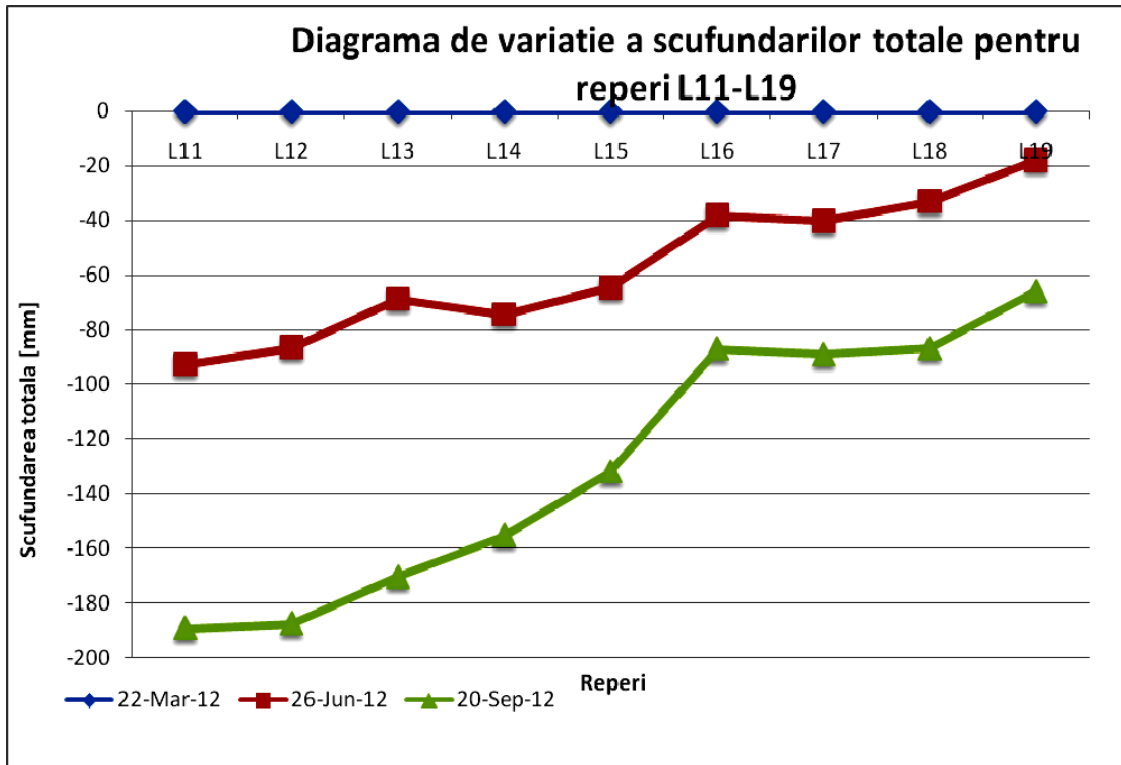
Landmarks of the median and hill top area, area for grazing, presents significant morphological changes highlighted by bumps, tears, cracks and landslides and due to these phenomena that occur frequently, high values of immersions are recorded (Fig. 1).

Fig. 1. Evolution of Landmarks Displacements for the Period 06.26.2014-09.20.2014

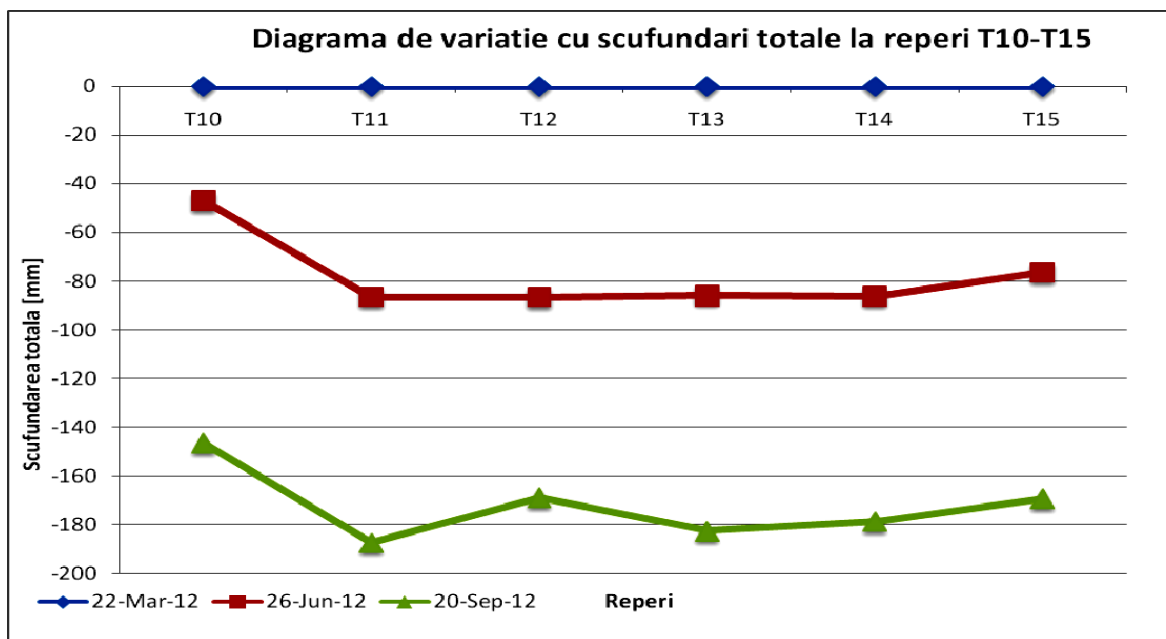
Fig. 2. Evolution of Landmarks Displacements for the Period 03.22.2014-09.20.2014

The variation charts indicate that these landmarks on these two alignments placed in the middle area of the influence field of Victoria mine, are in a continuous vertical displacement, registering maximum immersion in a short period of time (Fig. 2).

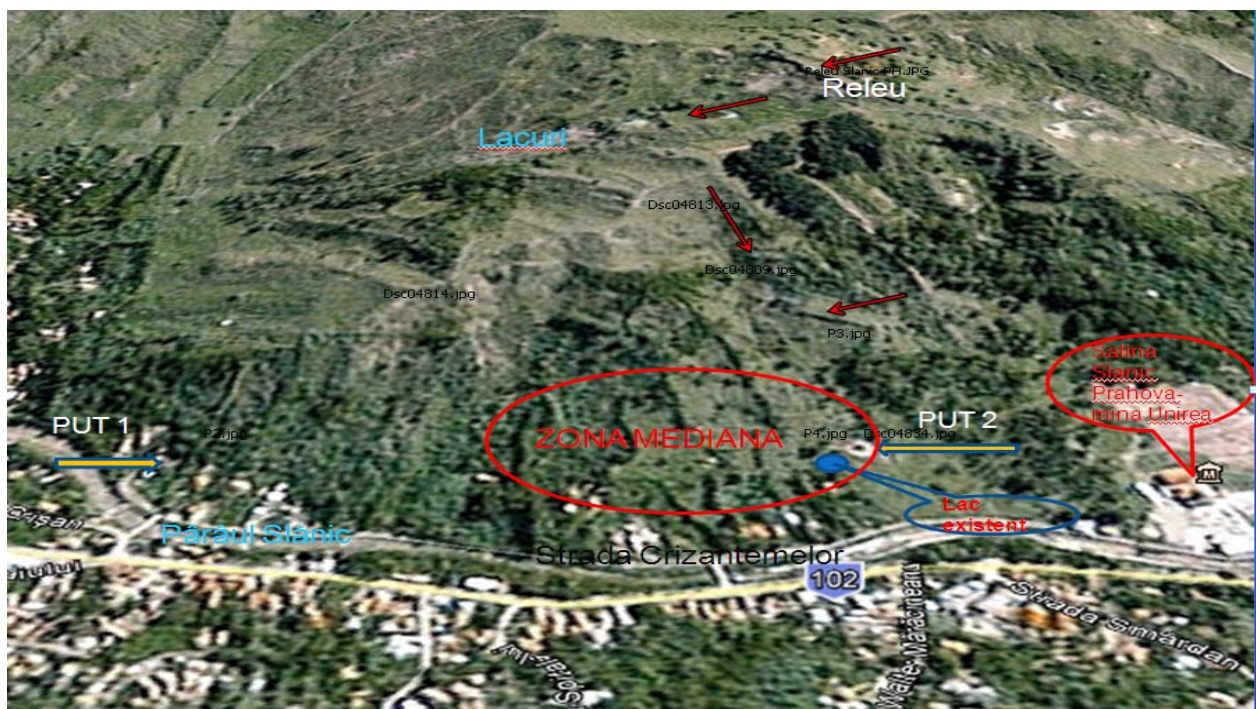
Maximum vertical displacements (time immersion from June to September 2014 and total immersion from March to October 2014) were recorded at landmarks placed in the middle area of the influence field of Victoria mine (Table 2, Fig. 3).

Fig. 3. The surface associated to Victoria - Slanic Prahova mine

Following the immersion values obtained in the four traced reports are highlighted on the situation plan, three areas labeled A, B, C where the dives recorded are maximum and the morphological changes of land are continuous.

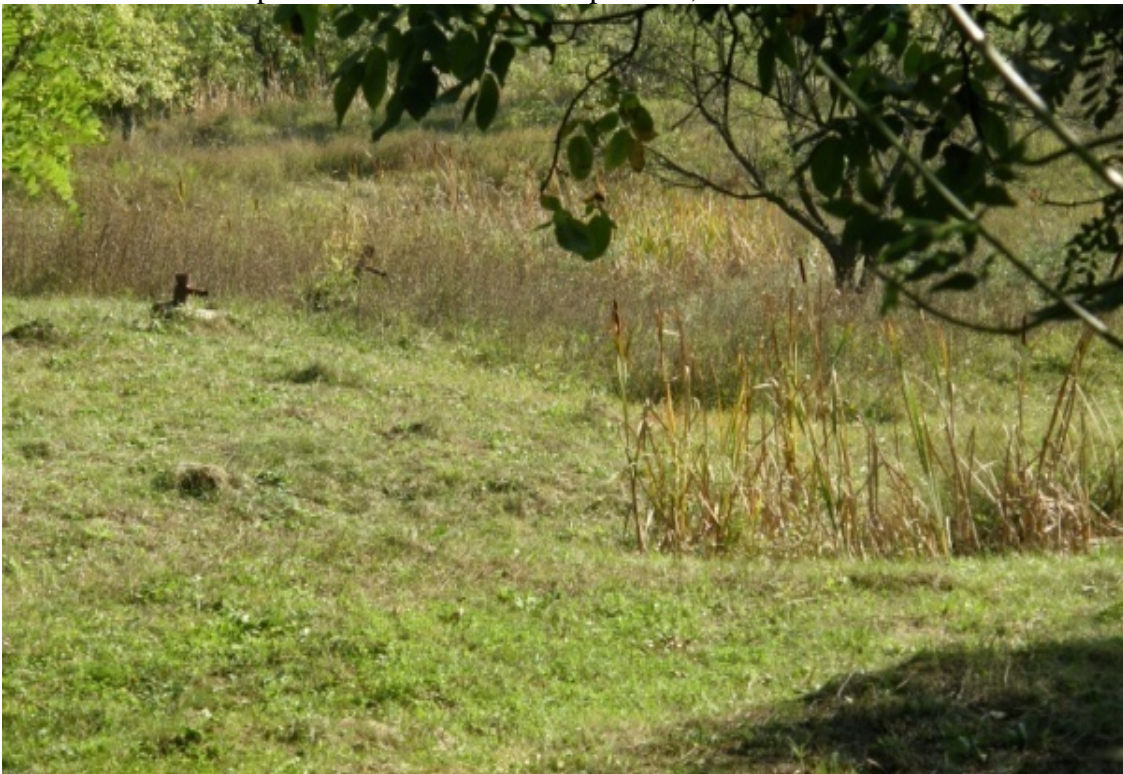
- small depression areas with water puddles;

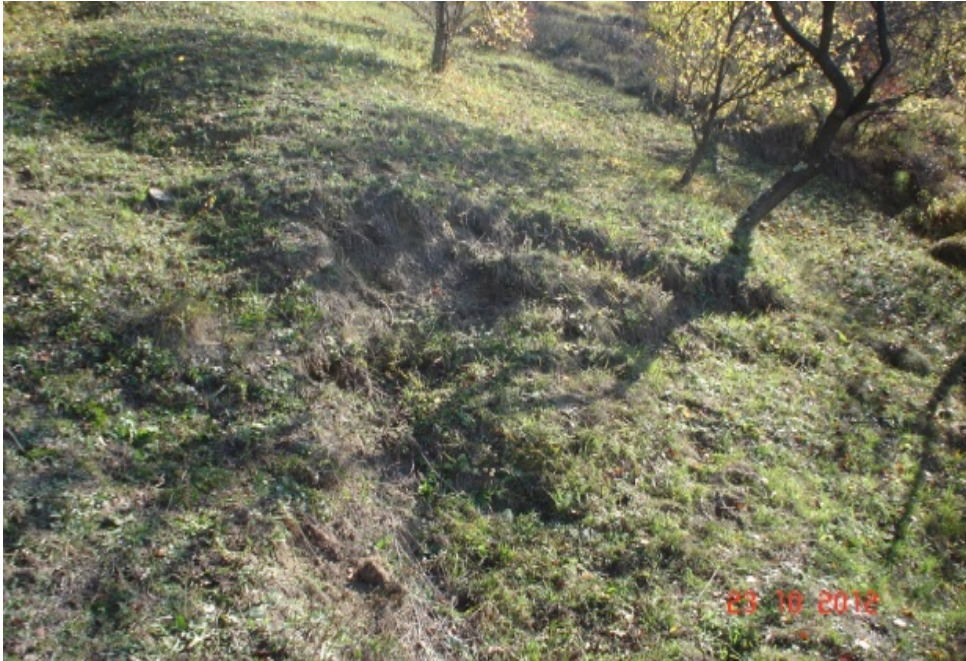
- landslides;

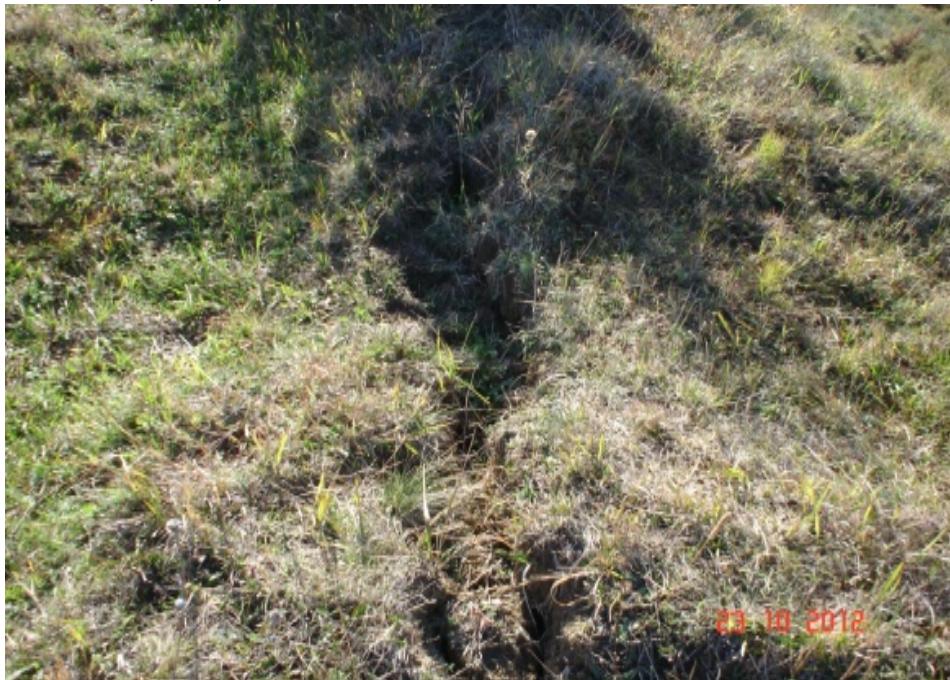
- cracks, cuts;
