UPDATE OF THE TOPOGRAPHIC PARAMETERS OF THE STRUCTURAL ELEMENTS TO THE PIPES NETWORKS

Abstract: *The paper presents a way of updating the parameters of representation and tracing of the structural elements to the water supply networks in the execution or rehabilitation phase. Between the design phase and the construction phase of the pipe network components there are divergences in the field tracing. This situation arises, in particular, in the execution of rehabilitation works for water supply pipes. The case study on the rehabilitation works of the Timisesti - Iasi adduction pipeline that underlines the river Moldova confirms the necessity of changes in time of the topographic documentation of the execution. The morphological changes of the Moldova River bed during the period between the implementation of the rehabilitation project and its application in practice necessitated the modification of the situation plan and of the longitudinal profiles. The updating of the topographical documentation was carried out during the start of the execution of the works (plans for the location of the constructions and installations) and then during the rehabilitation works (longitudinal and t

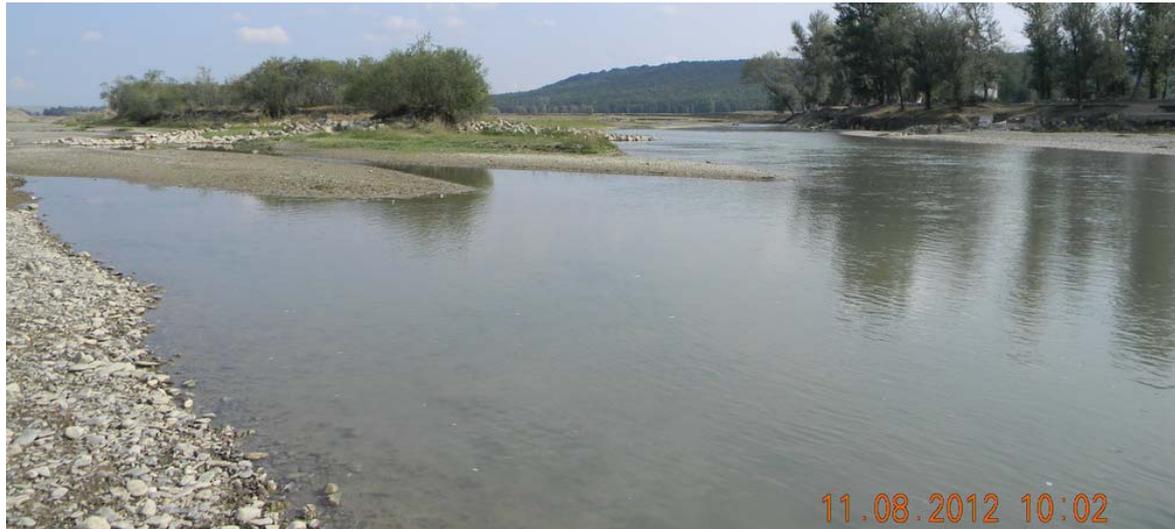
Fig. 2. Downstream general overview of the Moldova riverbed in the undercrossing area of the three adduction pipes (Photo Luca M., 2012).

The Moldavian River presents two separate whites of an island in the undercrossing area (Fig 2, Fig. 3 and Fig 4.b). The shape of the river bed was modified in 1970 (Fig. 4.a) when the second conduction pipe was executed. The left arm of the river is more developed (it was the main course of the river) and takes up about 70% of the conveyed flow. The right arm of the river was created artificially, and in small waters it has a low flow. The length of the undercrossing area is about 140.0 - 155.0 m, and the length of the regulated bed of 400.0 m. The distance between the three undercrossing pipes is 25.0 m (Fig. 1). The riverbed of River Moldova has an average width of 110-120 m in this area. The left and right banks are protected by simple concrete slabs.

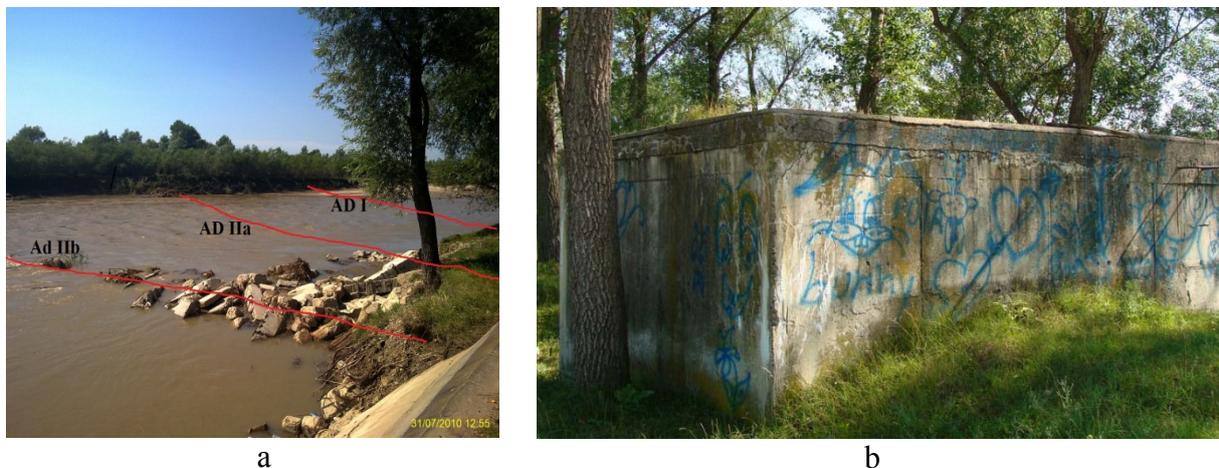
Fig. 3. Elements of placement of the Timisesti - Iași adduction pipeline in the riverbed of Moldova River: a - pipeline layout on the left arm of the river; valve houses situated on the left bank.

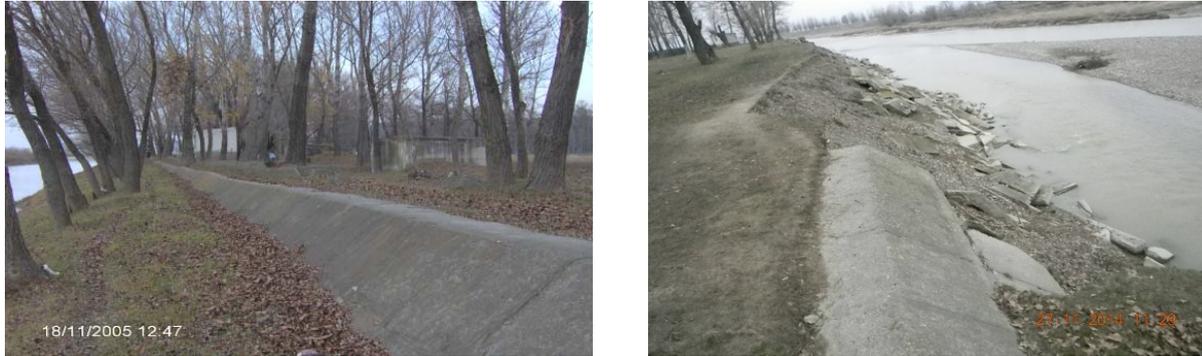
Figure 5. General view of the evolution of Moldova's river bank to the effects of floods: stable in 2005; b - eroded in 2012 (Luca M., 2016).

Research on the hydrodynamic erosion phenomenon of the bed between 2004 and 2015 necessitated the updating of the situation plans, especially of the right bank route. Starting with 2004 there was a strong erosion of the right bank, as a result of the floods formed on the Moldova. The shore protected by shore defense works was continuously eroded on depths of 4.0 - 15.0 m (Fig 5). The action of the water caused the alluvial cleaning (Fig. 5.a), the breaking of the shore protection and the river bedside flow (Fig. 5.b).

The phenomenon of hydrodynamic erosion has degraded the riverbed vertically and horizontally. The vertical erosions caused the bottom of the bed to be lowered by about 1.50 – 3.20 m. This led to the unveiling of the adduction pipes located in the bed and their degradation (Luca M., 2012).

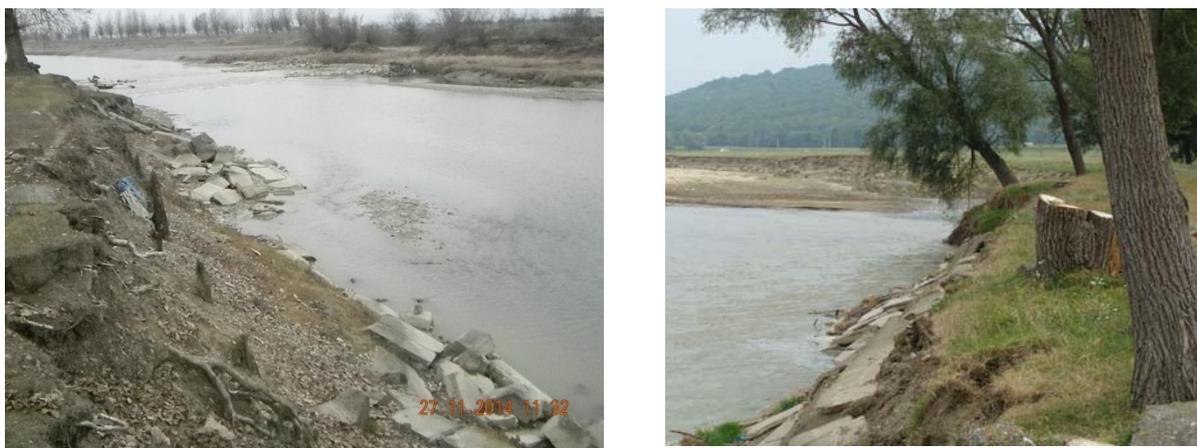
Fig. 7. Details of the erosive water action on the left bank of the river Moldova upstream of the undercrossing of the adduction pipelines: a - defence of total degraded river (2012); b - left eroded with the collapse of shore defence (2012) (Luca M., 2012a).

- the second update was made on the left and right bank cross-sections, given the erosive water action caused by the floods in the period 2012-2015; cross-sectional shore profiles are used by the builder to carry out shoreline defense work, and land shares must be as accurate as possible to obtain the actual volume of construction material; the transversal river crossing profile in October 2012 no longer corresponds to the one existing in 2015 in April (Fig. 7).
