RESEARCH ON THE TOPOLOGY OF EARTH DAM BY USING GNSS TECHNOLOGY

Abstract: *Monitoring and assessment of the operational safety of hydrotechnical constructions made of earth and local materials requires geodetic measurements at specified intervals. Among these hydrotechnical constructions are the earth dams which have many negative events. A high percent of accidents in Romania occur at small earth dams. Monitoring the topology of earth dams is done by classical geodetic methods. But, in recent times, new technologies have emerged to track the topology of earth dams, of which GNSS technology stands out. Research conducted with GNSS technology, to monitor the geometric parameters of a dam in the Moldova area, has highlighted the reliability of the method by the accuracy of the results and reduced working time. Field research conducted at the Podisu Dam in Iasi county, in conjunction with documentary studies on the evolution over time of the topology of the earth dam showed important changes with an influence on the stability of the construction. Interpretation of the data obtained by measurements showed a change in the geometric shape in the horizontal plane and in cross sections. Th

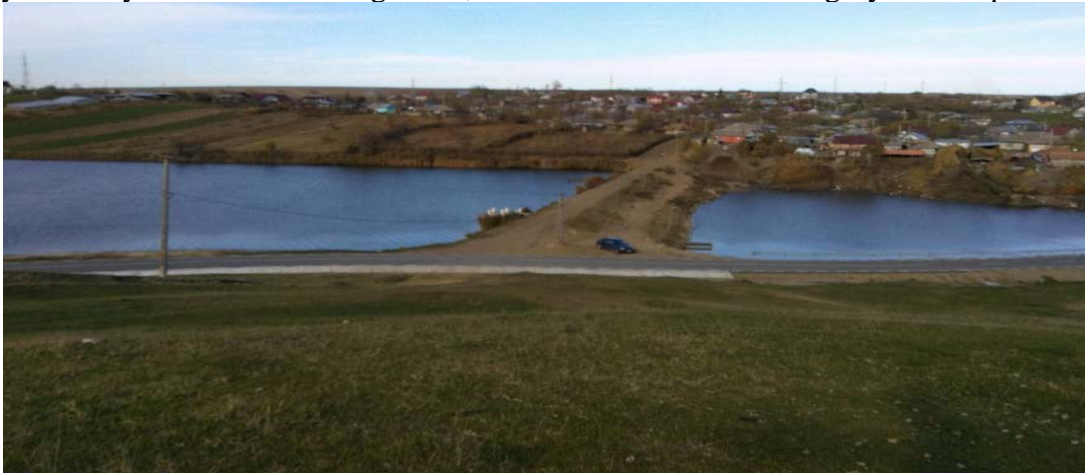
Figure 3 – General view of the Podisu dam (source: author)

Podisu accumulation (Fig. 3) was designed and built between 1961-1962 with the main function of fish farming and secondary flood control on the Sheep Valley River. According to the technical expertise carried out in 2006 [14] in order to assess the operational safety of the hydrotechnical arrangement, it falls into the normal category C of importance.

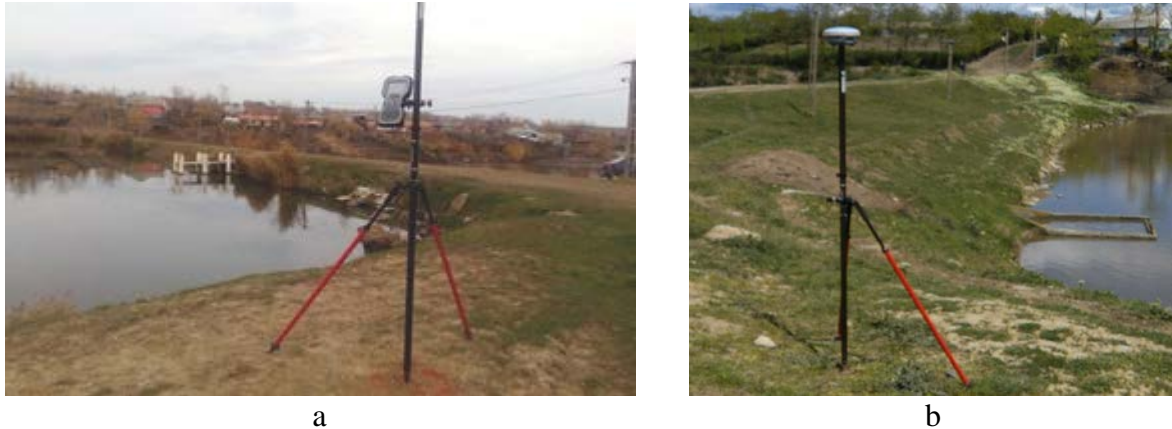
Figure 11 – The condition of the slopes at Podisu dam in 2021: a – upstream slope; b – downstream slope (source: author).

- The research carried out on the topology of the downstream slope of Podisu earth dam (Fig. 11.b) highlighted the following:

- 1. The downstream slope of the dam was designed with a slope of 1:2. Measurements carried out in 2006 showed a change in the slope through settlement processes. This situation is highlighted in $P_{t,1}$ and $P_{t,2}$ profiles.
- 2. In 2021 a berm was also found in the $P_{t,3}$ profile.
- 3. In 2021 the downstream slope was modified by embankment filling works and the berm was thus strengthened.
