THE STUDY OF THE DEGREE OF SILT SEDIMENTATION IN THE PUBLIC RESERVOIRS OF THE REPUBLIC OF MOLDOVA

This article presents a study on the degree of sedimentation in the "Zagarancea" reservoir, located along the course of the Vladnik River, within the administrative territory of the Zagarancea commune in Ungheni County (figure 1).

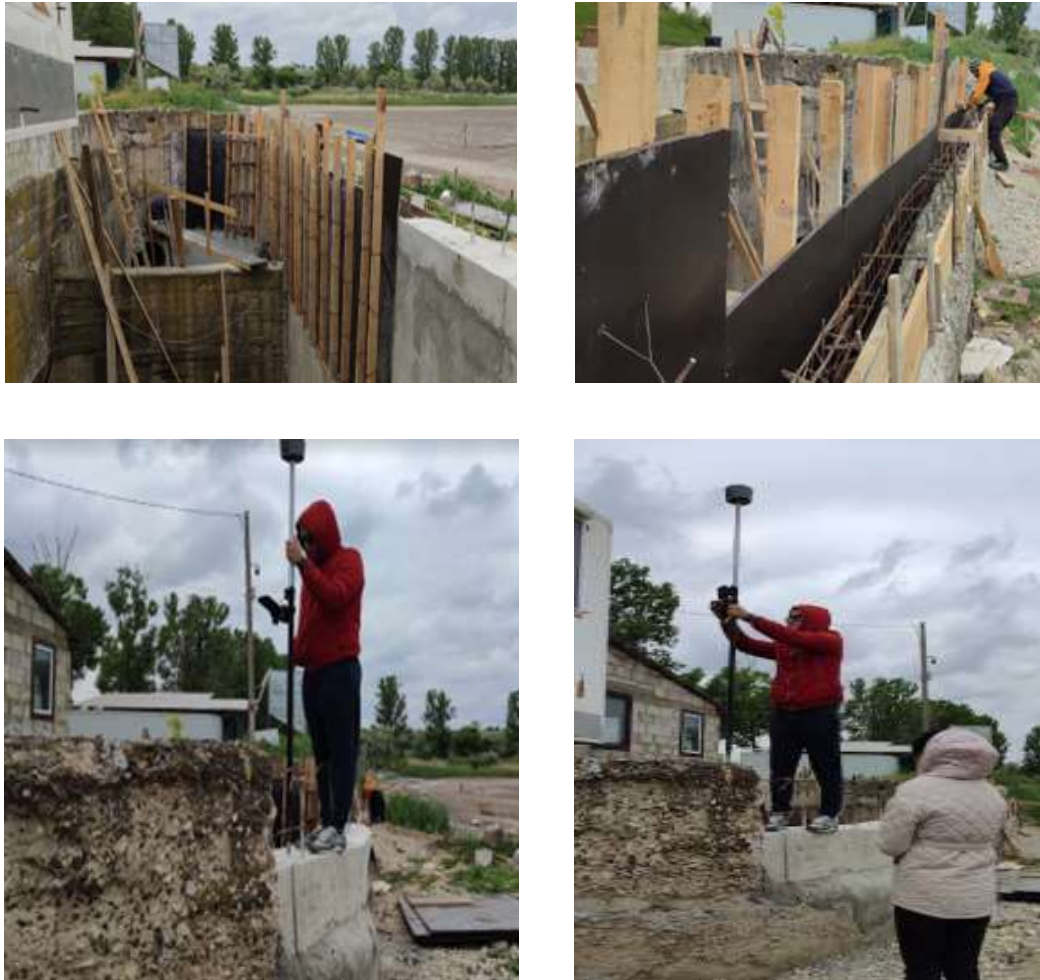
The dam of the reservoir has been assessed from a technical standpoint. Following the evaluation, rehabilitation activities are currently underway, involving the installation of a reinforced concrete layer on the interior walls (figure 2). Additionally, a concrete tie beam is being constructed on the upper side, in which metal bars are embedded for the future installation of a protective grill. The coordinates and elevations of these dam elements have been marked and verified topographically (figure 2).

Figure 2. Geodetic works for the rehabilitation of the large water spillway structure, including the surveying and verification of characteristic points

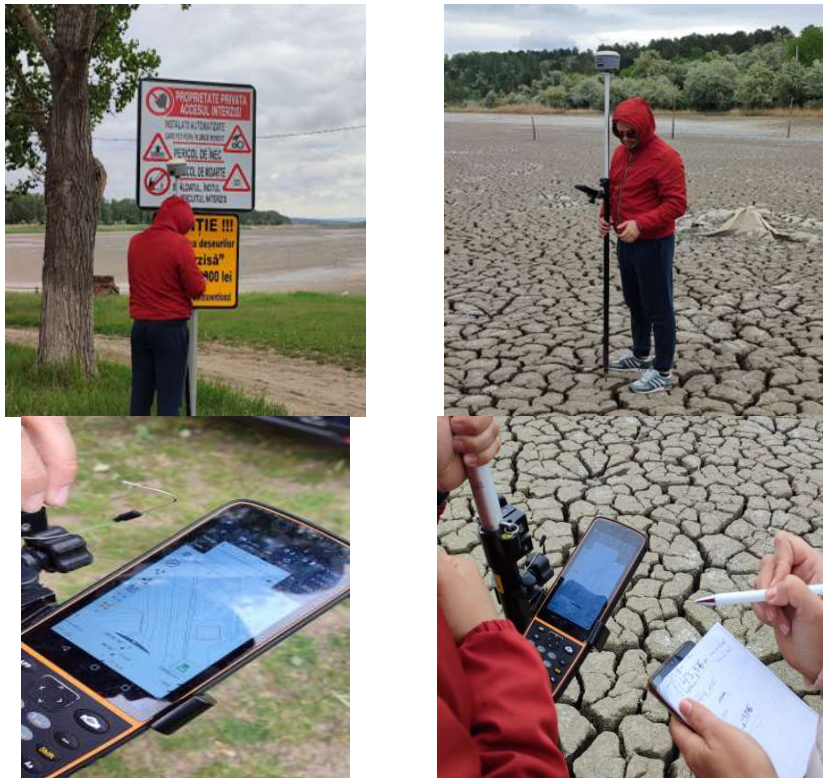
Topographic measurements focused on the land surface around the lake, its banks, and the dry lake basin. The goal is to detail the area's relief to understand water flow and erosion. The measurements were conducted in May 2024 (figure 3) using the CHCNAV I50 GNSS receiver and the MOLDPOS [6] positioning system, to develop the topographic map of the current field situation and to compare the elevations of characteristic points with previous cartographic materials.

Figure 3. GNSS measurements of the Zagarancea reservoir

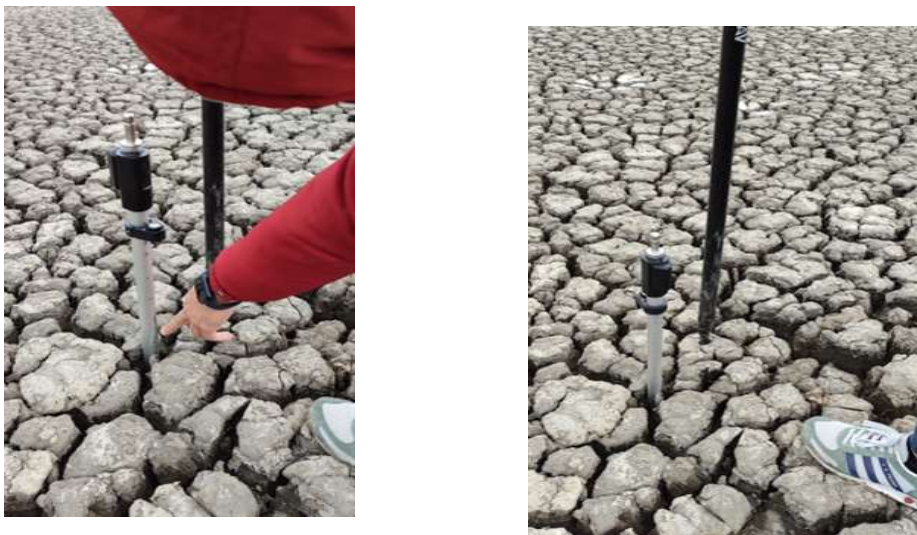
At the same time, some bathymetric measurements were conducted (figure 5) to determine the depth of the sludge (sediment deposition) along the lake basin. The variation in sediment levels is approximately between 0.80 and 1.00 m relative to the bottom of the lake basin, according to the project documentation.

Figure 5. Bathymetric measurements

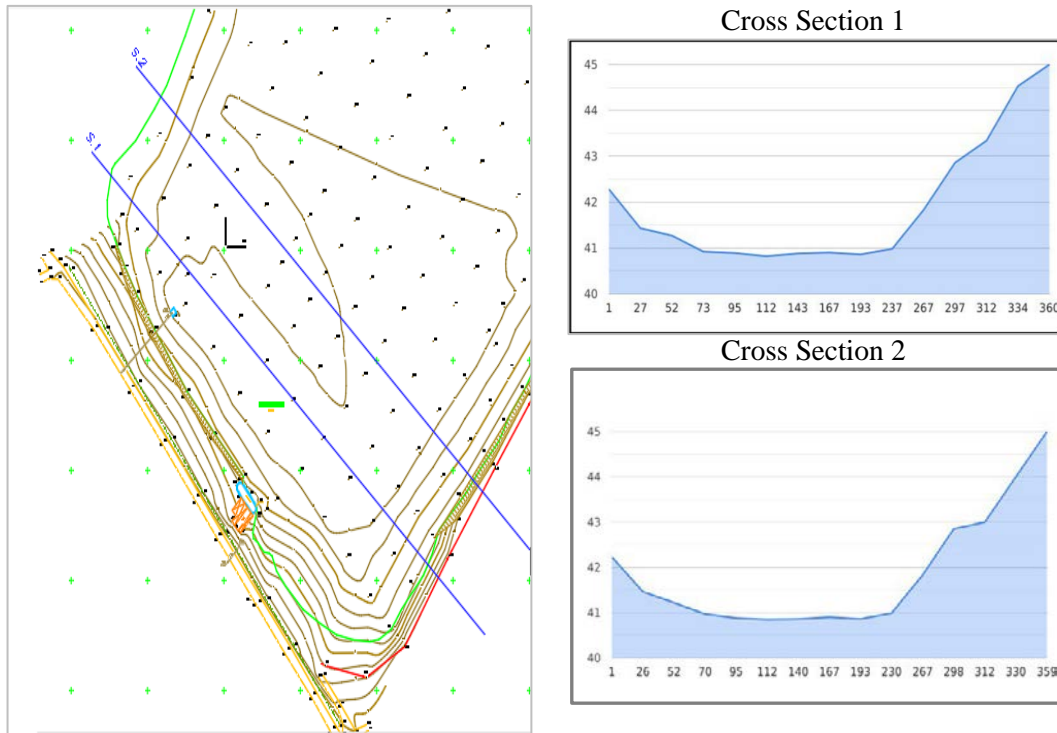
Due to the accessibility of the dry lake, topographic and geodetic measurements were conducted on two cross sections to develop the cross profiles (figure 6), where the elevations are recorded vertically in the Baltic Sea height system, while the horizontal axis indicates the points where GNSS observations were made.

Figure 6. Cross Profiles

The cross profiles created revealed remarkable variations in sludge depth, ranging from 0.80 to 1.00 m in different areas of the lake. This information is essential for planning cleaning and rehabilitation interventions, providing a visual guide to the distribution of sediments and the most affected areas.
