HIGH-PRECISION GEODETIC MEASUREMENTS PERFORMED IN THE INITIAL OBSERVATION CYCLE FOR MONITORING THE HORIZONTAL DISPLACEMENTS OF THE ENCLOSURE AND COUNTERSCARP WALLS OF THE SUCEAVA SEAT FORTRESS

Abstract: *For the purpose of determining the horizontal displacements of the enclosure and counterscarp walls of the Suceava Seat Fortress, high-precision geodetic measurements were required. Thus, a local geodetic monitoring network was designed, materialized, and determined to obtain the planimetric positions of the control points placed on the mentioned walls, which will serve as reference points for future observation cycles.*

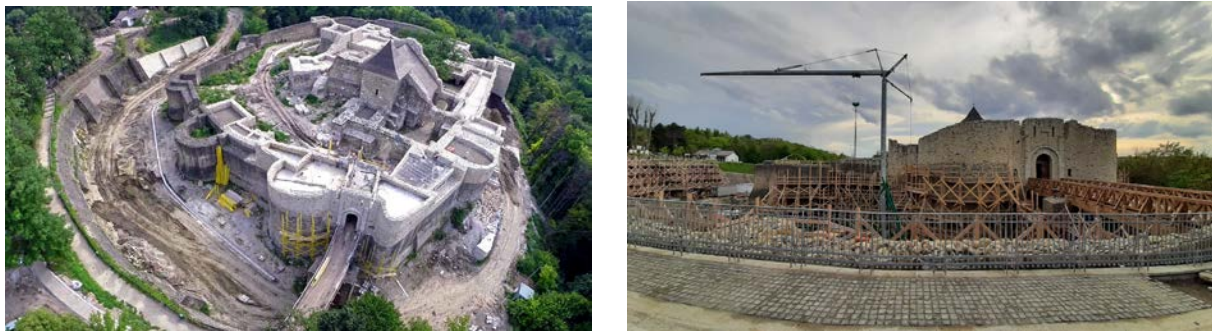
Fig. 1 Executution of rehabilitation/consolidation works at the Suceava Seat Fortress

Given the technical assessment of the construction and the implementation of rehabilitation/consolidation works (Figure 1), alongside the Special Monitoring of Behavior over Time Project No. UCT204/2022, which requires high-precision geodetic measurements to monitor the evolution of horizontal displacements, specialized geodetic measurements were conducted on 12.12.2024. The objective of these measurements was to establish the local geodetic monitoring network and, consequently, to develop the comparison plan for subsequent measurement cycles.

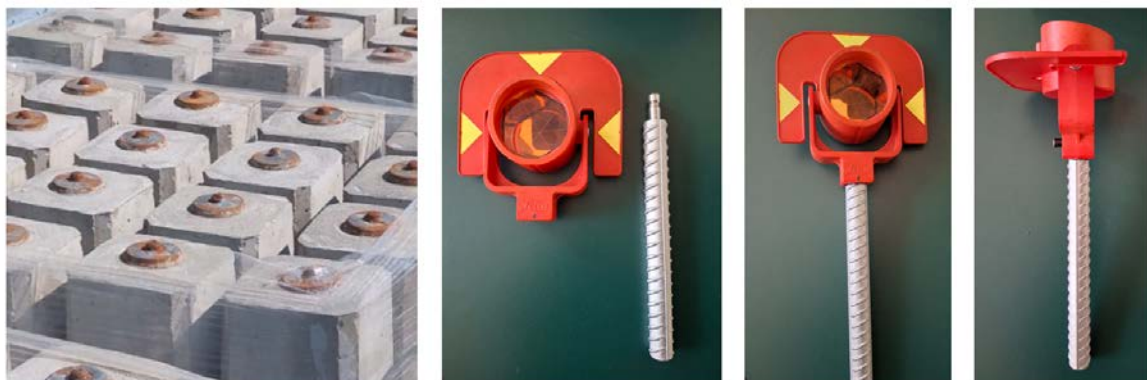
Fig. 2 Preparation of geodetic equipment for monitoring horizontal displacements

The measurements were made using the Leica TCA 1100 total station, with an angular precision of 3" and a distance measurement accuracy of 2 mm + 2 ppm.

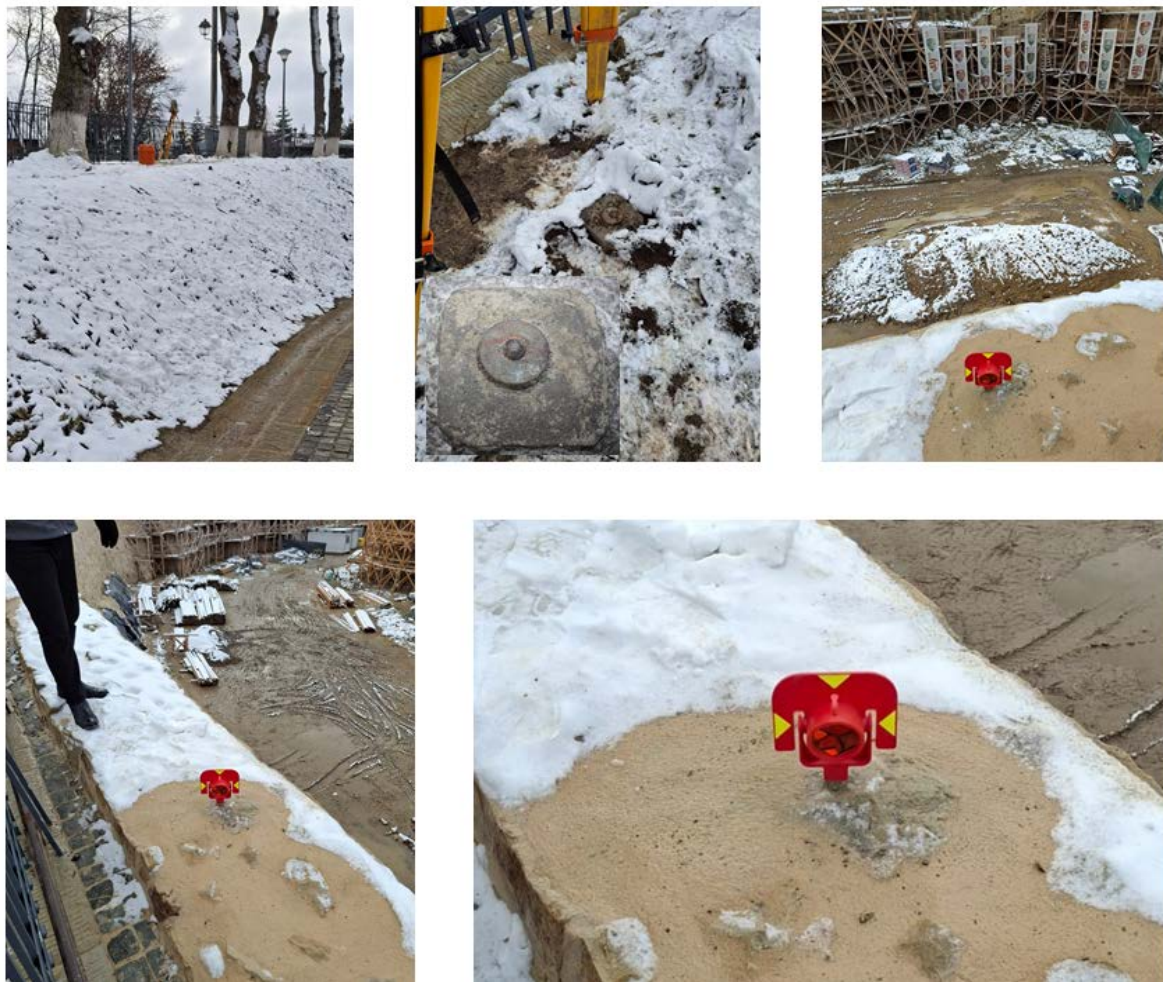
The high-precision geodetic measurements, related to the zero cycle, were carried out on 12.12.2024, between 09.30-16.30, a day characterized from a meteorological point of view by temperatures of approx. 0-2°C, moderate wind and cloudy sky (Figure 4).

Fig. 4 Aspects during the execution of measurements in the initial/zero observation cycle
