Aspects Concerning Rehabilitation of Old Masonries

Associate Prof. Eng. Ph. Dr. Proca Gabriela Technical University Jassy
Eng. Drd. Proca Cristina, Technical University Jassy

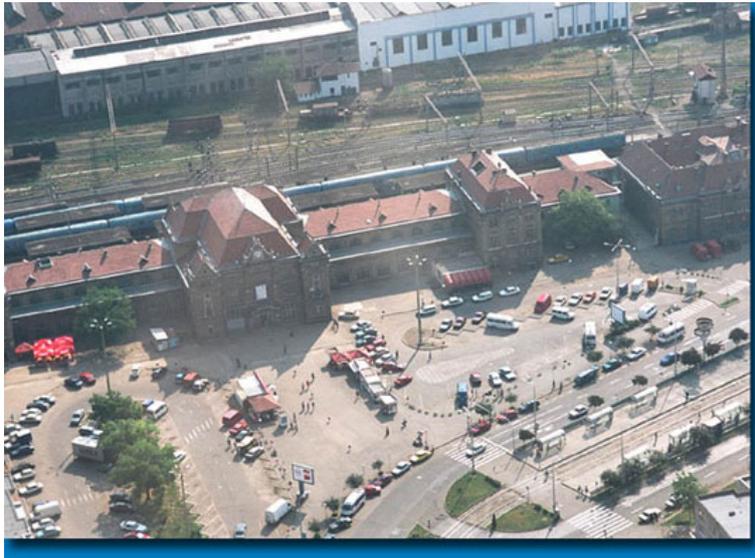
Photo 5 Arad Railway Station

The railway station, opened in 1858, set the northern point to the central axis of the town Arad. With its 96 km of railway, Arad reached the second place in the country, after Bucharest. The location of railway station is shown in Photo 5.
