RESEARCH OF MORPHOLOGICAL PROCESSES INTO THE MOLDOVA RIVERBED USING PERIODIC TOPOGRAPHIC MEASUREMENTS

Abstract: *The floods occurred on Moldova River, during 2004-2015 changed the minor bed in Soci area. In this area it is embedded the undergoing Timișești-Iași adduction pipe. The undergoing section morphological changes have influenced the vertical and horizontal minor bed stability. Morphological changes were monitored by topographical surveys. The leveling surveys of research area were updated after each flood. There were made cross section and longitudinal section of the riverbed in the research area. By processing the topographical series of surveys it result the riverbed changes under the action floods. The longitudinal and cross sections indicated the riverbed hydrodynamic erosion parameters. The data collected and processed allowed the design of the breastwork in the area where the headrace ducts under-cross the river.*

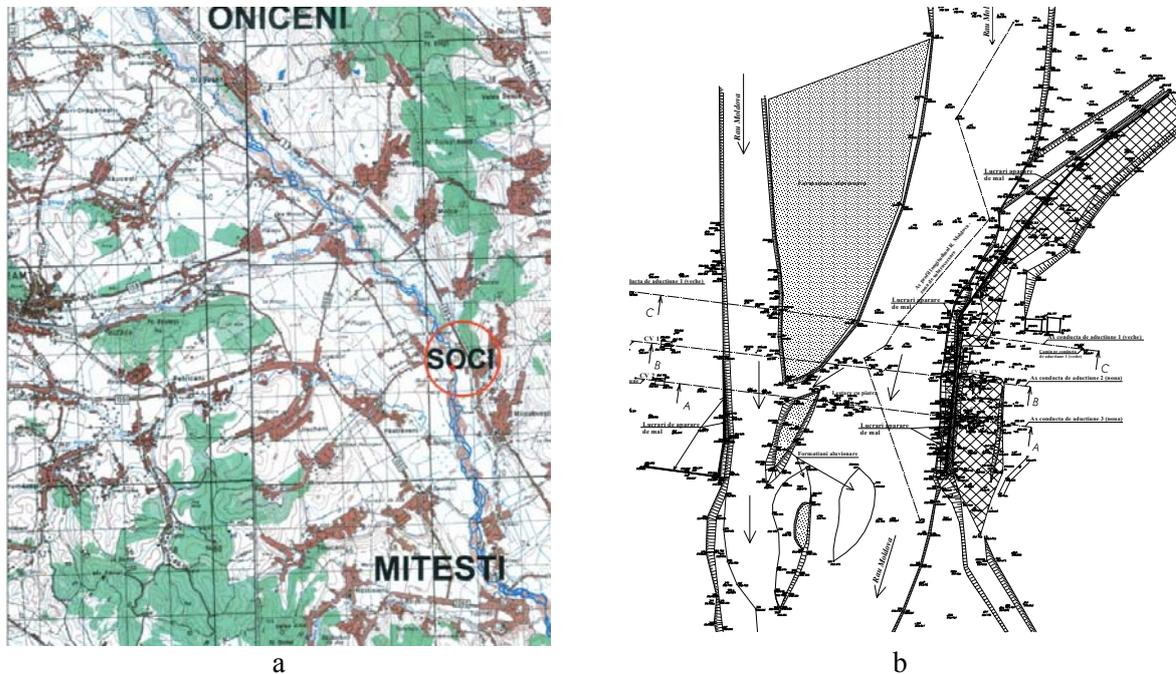
Figure 1 Map of studied area: a – research area on the Moldova River; b – Land survey on investigated river section in 2005.
