CONSIDERATIONS ON NON- DESTRUCTIVE MONITORING METHODS USED IN MASONRY STRUCTURE CONSTRUCTIONS' EXPERTISE OF THE EXISTING BUILDING STOCK

*Gabriela Ecaterina PROCA, Assoc.Prof.Ph.Dr.Eng., Technical University "Gh.Asachi"
Jassy, gabriela_proca@yahoo.com*

Abstract: *In the context of building construction works from existing building stock, the paper presents considerations regarding the monitoring methods used in heritage buildings in Romania and constructive implications necessary for structural consolidation.*

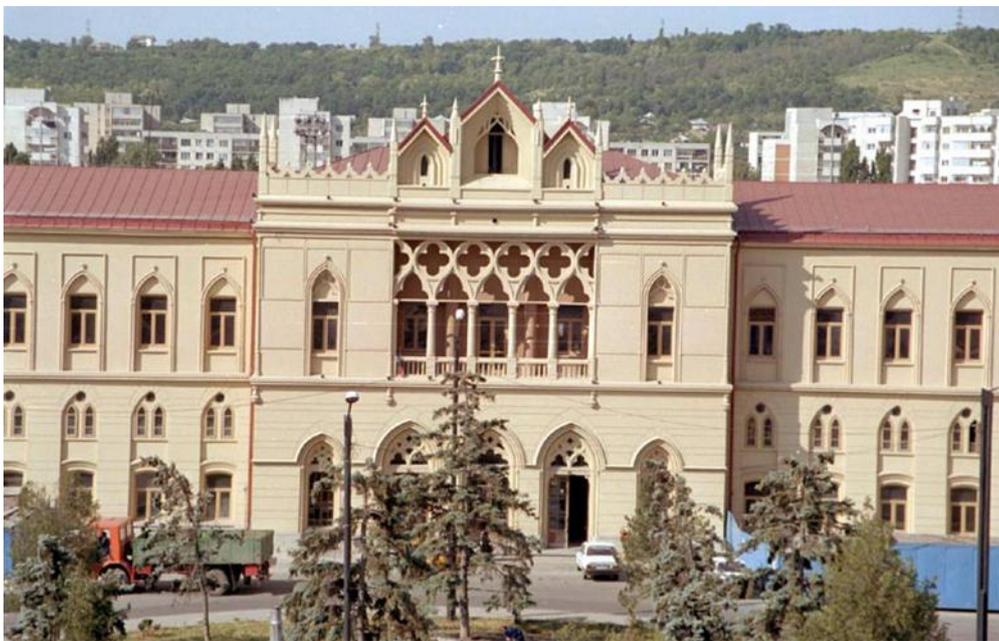
Fig 1. The main building of Jassy Rail Station

Seismic activity, earthquakes that occurred since 1977 and raising the ground water up to the level of the foundation situated on upper terrace Bahlui river that contains silt loam characterized by pronounced sensitivity to water were the main causes of structural damage resistance and finishes.
