ASSESSMENT OF HYDROMORPHOLOGICAL AND HYDRODYNAMIC ALTERATIONS CAUSED BY ANTHROPOGENIC INTERVENTIONS ON THE RIVERBED. CASE STUDY DANUBE BALA BRANCH NEW BOTTOM SILL

Abstract: *The necessity for navigation conditions improvement on the Lower Danube lead to the construction of a submerged bottom sill on the Bala branch. This paper presents differences that occurred between riverbed bathymetry and water current velocity values recorded in measurements campaigns using multibeam and ADCP techniques carried out before and after the bottom sill was built (June 2013 and March 2016). The comparative hydromorphological analysis showed the emergence of erosion areas up to -17.4 m and deposition areas up to 9.5 m. As for the hydrodynamic alterations, above the new built bottom sill, the water current velocity values of over 3.0 m/s were recorded.*

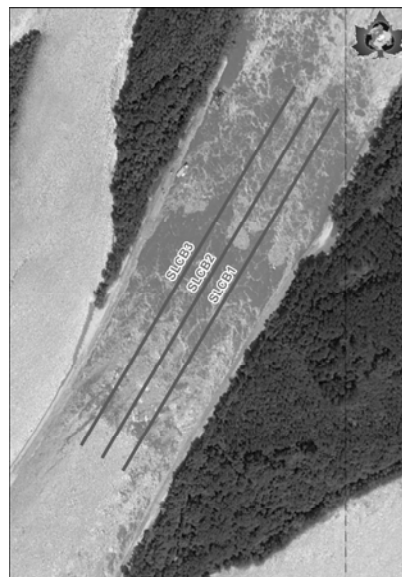
Fig. 1. Longitudinal control sections location on Danube Bala branch

In this paper, there are used longitudinal transects recorded on the same track in both measurement campaigns, as shown in Fig.1.
